Evaluation of an embedded culvert's performance¹

Clayton Gillies

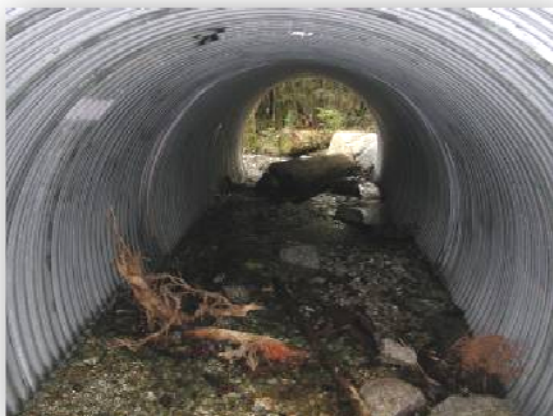
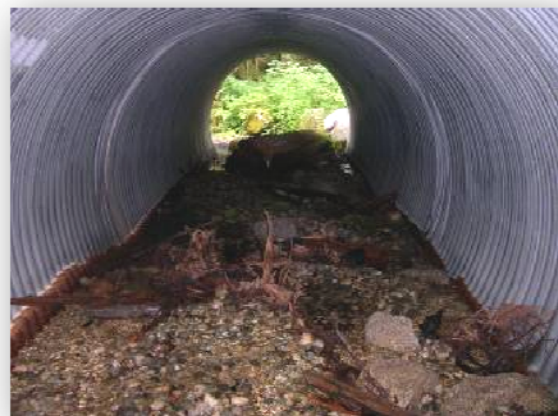
The composition of the infill material remains similar to that of 2002; it is made up of gravel and cobble-sized material with boulders and woody debris spread throughout (Figures 1a and 1b). The 2002 measurements showed that both the simulated streambed and culvert were constructed at a flatter gradient than the natural stream. As well, infill material was delivered to a greater depth within the culvert at the outlet than the inlet, which resulted in the simulated stream gradient being less than the culvert's. The simulated stream has become slightly steeper (now 2.8%); infill material has moved from the outlet area and additional bedload material has deposited at the inlet area (Table 1). When a culvert is embedded and infilled to the level of the natural stream, it is expected that bedload will move through the culvert as it would the natural stream, including scour and deposition areas. The gradient differences measured between the natural stream, simulated stream, and culvert highlight the need for vertical control during construction.

Figures 1a (left) and 1b (right). Looking towards the outlet during 2002 (1a) and 2008 (1b). Despite very heavy rain events since construction, the composition and flat nature of the simulated streambed has not changed significantly over six years; much of the woody debris and boulders are in similar positions.
