A Forest Engineering Analysis of Landslides in Logged Areas on the Queen Charlotte Islands, British Columbia

by
R.K. Krag,
E.A. Sauder,
and G.V. Wellburn

August 1986

FERIC Special Report SR-39

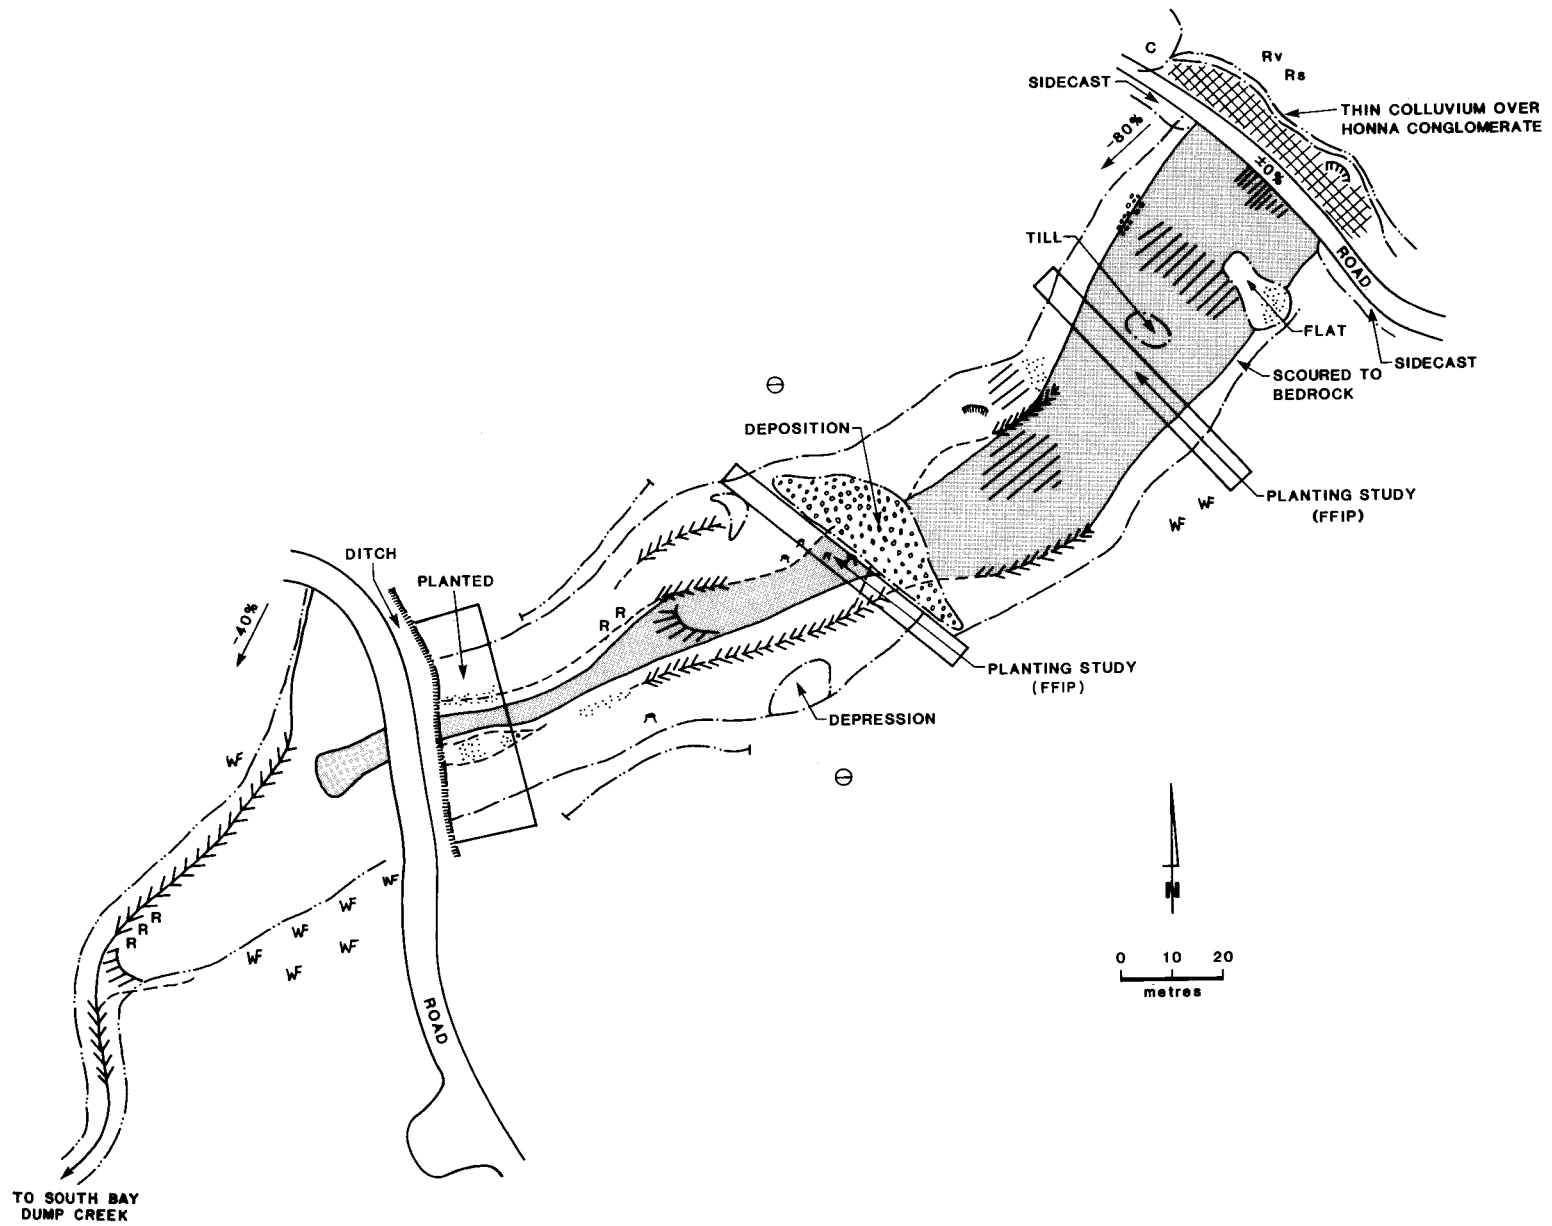
FIGURE A4.1. Diagram of Example #1, South Bay Dump Creek. (Failure #4, L13-117/116)

This failure typifies landslides that were considered to be caused principally by overloading. The principal features of the failure site were very steep slopes (>75%), highly weathered bedrock, and shallow noncohesive soils, coupled with sidecasting of excess material. The failure probably occurred during wet weather, but the available evidence indicated that surface drainage from the road and surrounding area was not a contributing factor.

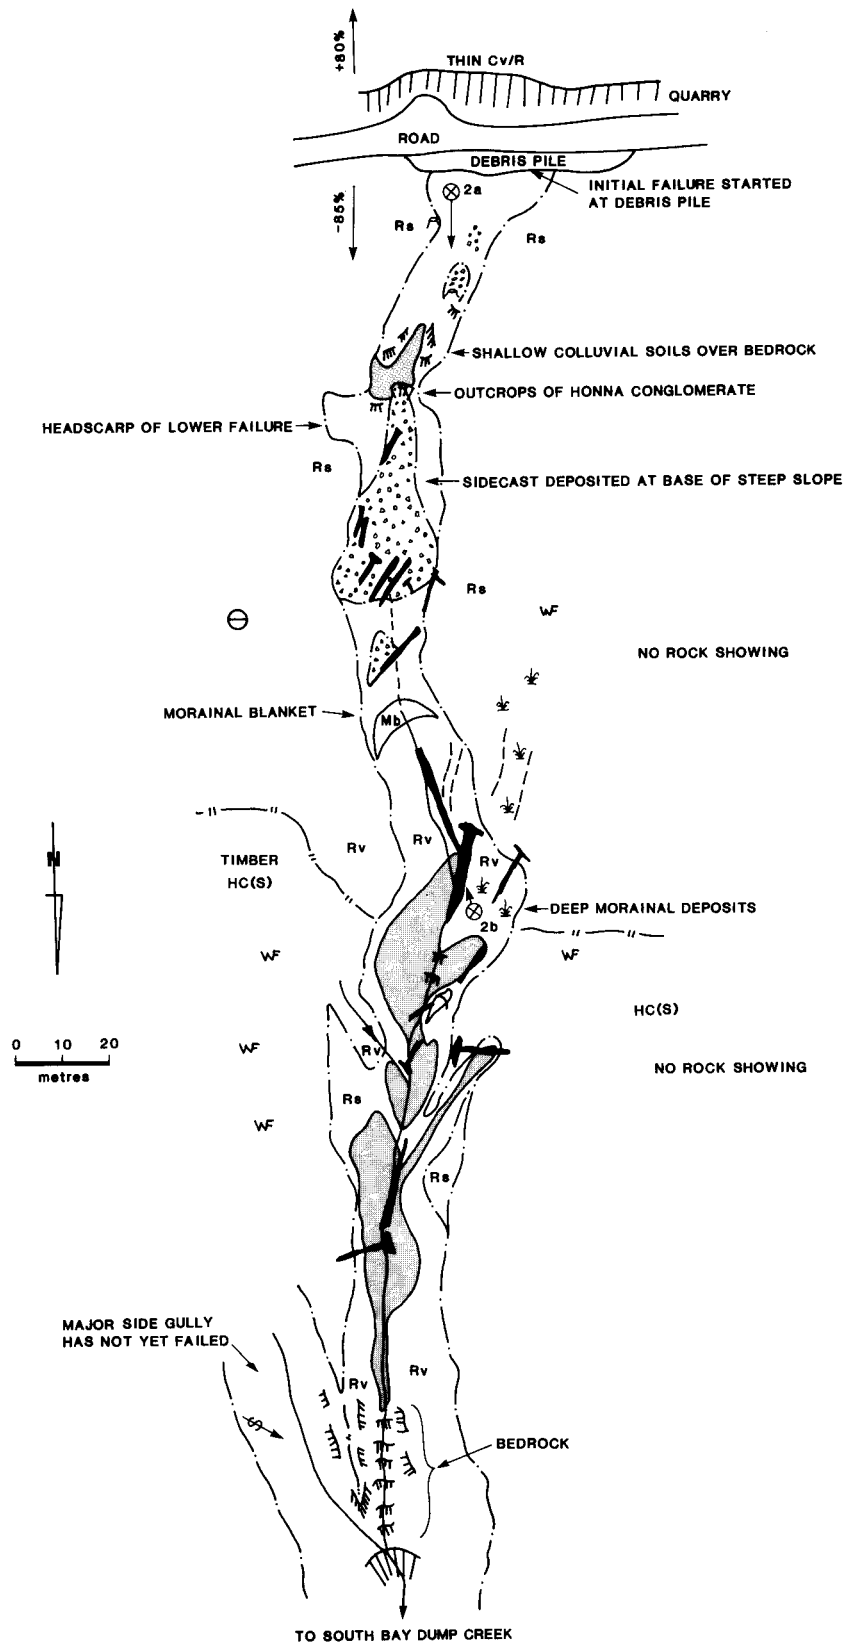
FIGURE A4.2. Diagram of Example #2, South Bay Dump Creek.
(Failure #17, L13-116/115)

No surface or subsurface drainage was evident in the road cut or in the headwall of the slide, but surface water appeared in the scour zone near the base of the steep straight slope and increased in volume within the gully.

The slide was located near the middle of a 70-m section of road which had been quarried for ballast material. Waste material from the pit had been piled on the outer road edge. The road was fully benched on bedrock and drained water away from the failure site. It is not known what construction machinery was used, but presumably the ballast material and waste rock was handled by a front-end loader.

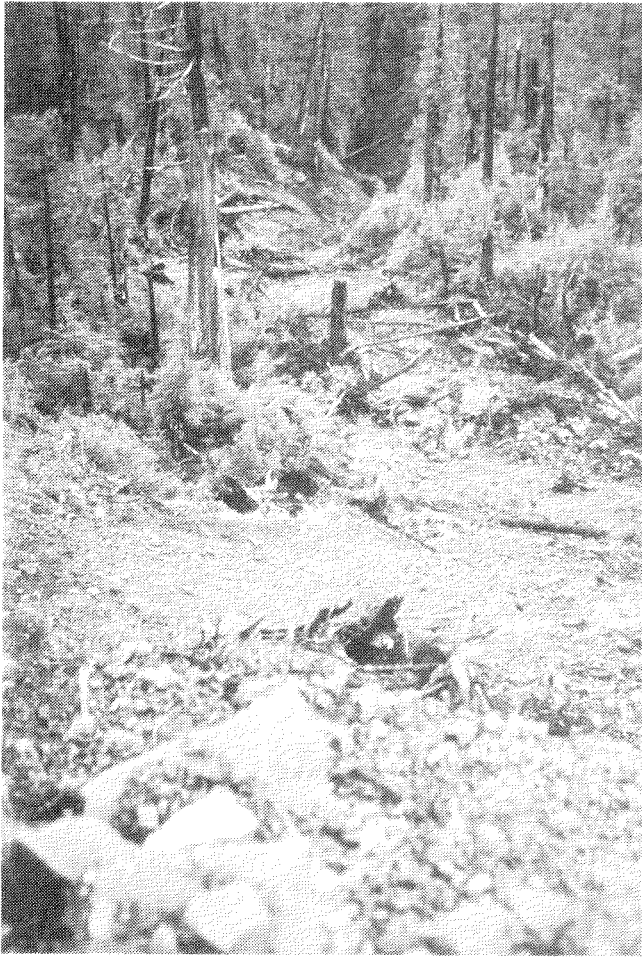
FIGURE A4.2a. Looking down
from road,
Example #2.

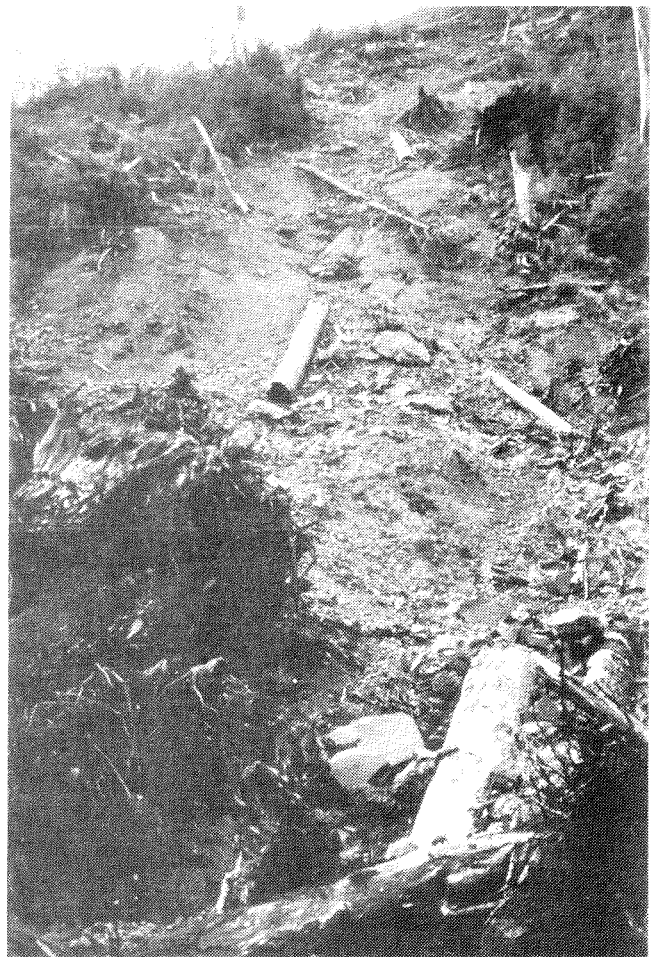
FIGURE A4.2b. Sidecast from
road enters initi-
ation zone of lower
failure, Example #2.

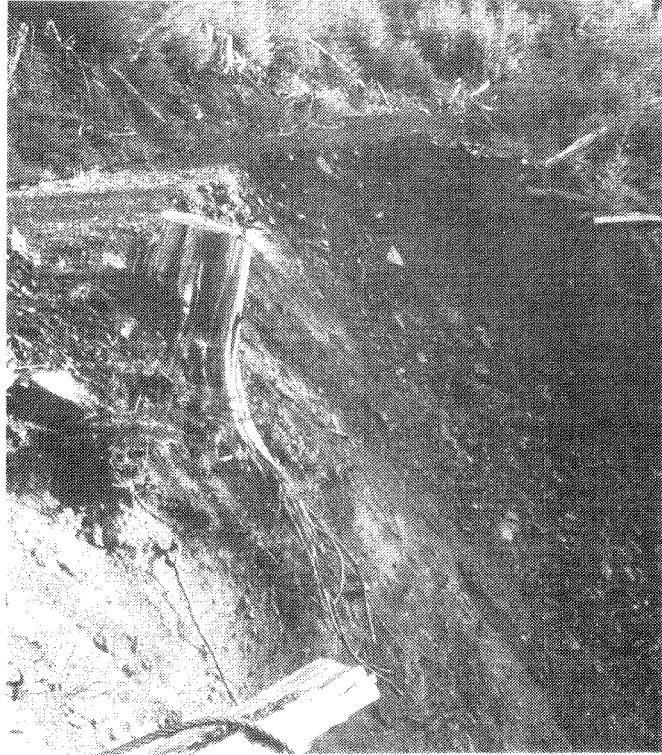
Three factors probably contributed to this failure: 1) construction of a deep fill within a drainage depression on a moderate to steep slope; 2) high site moisture levels draining over a compact, impermeable morainal deposit; and 3) inadequate allowance for road drainage during construction and after logging.

FIGURE A4.3a. Initiation zone, Example #3.

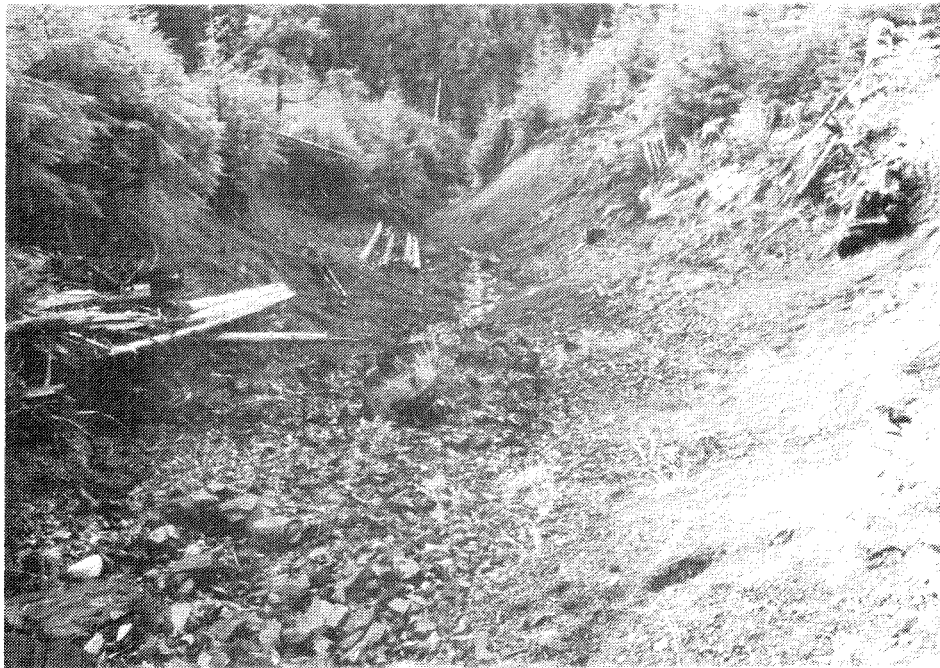
FIGURE A4.3b. Looking down slide channel, Example #3.

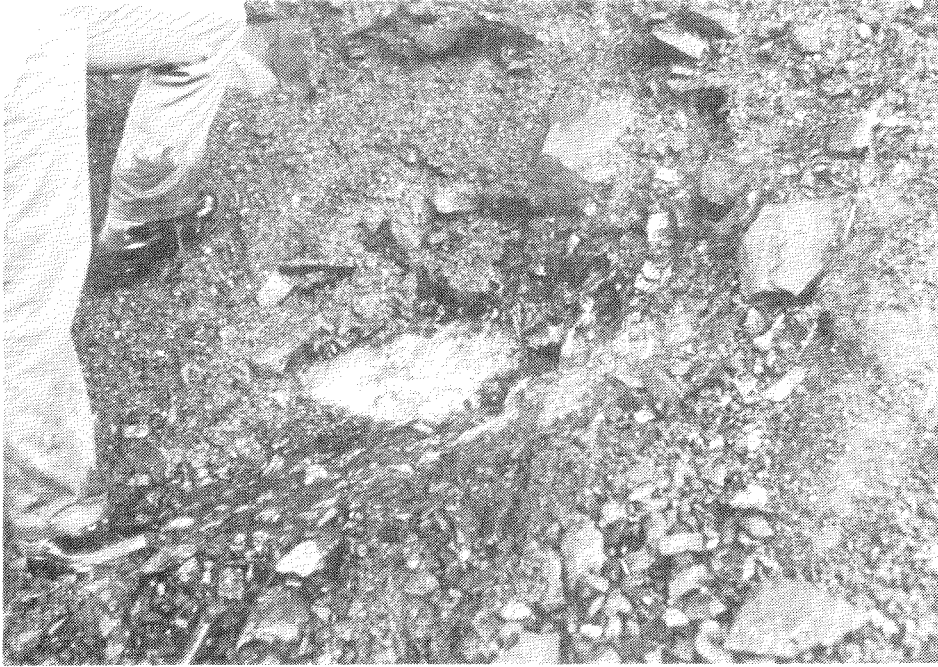
FIGURE A4.3c. Water flowing out of headscarp at the base of the ballast layer, Example #3.

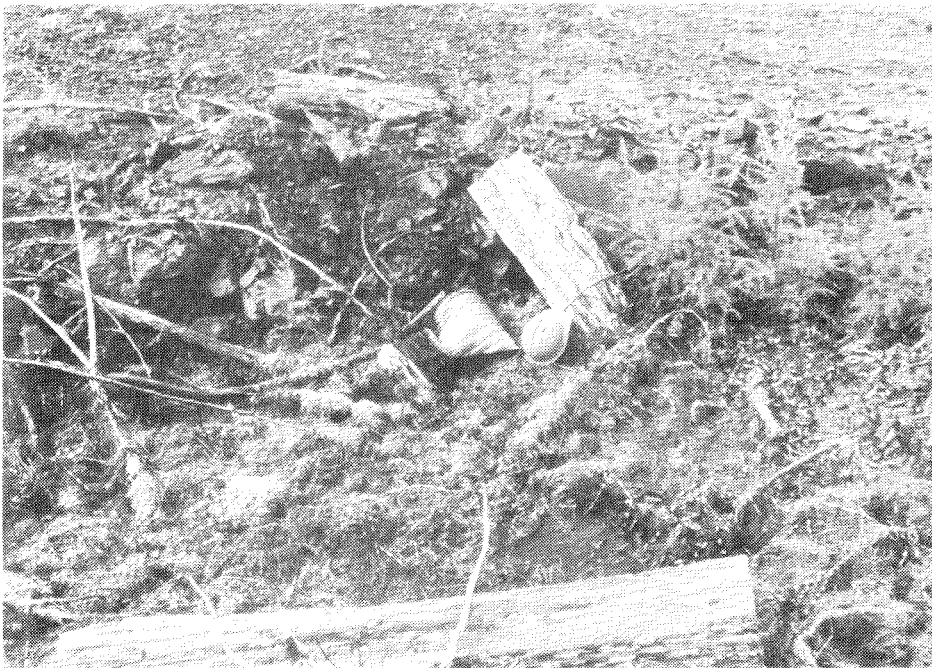
FIGURE A4.3d. Culvert inlet almost plugged with debris and sediment, Example #3.

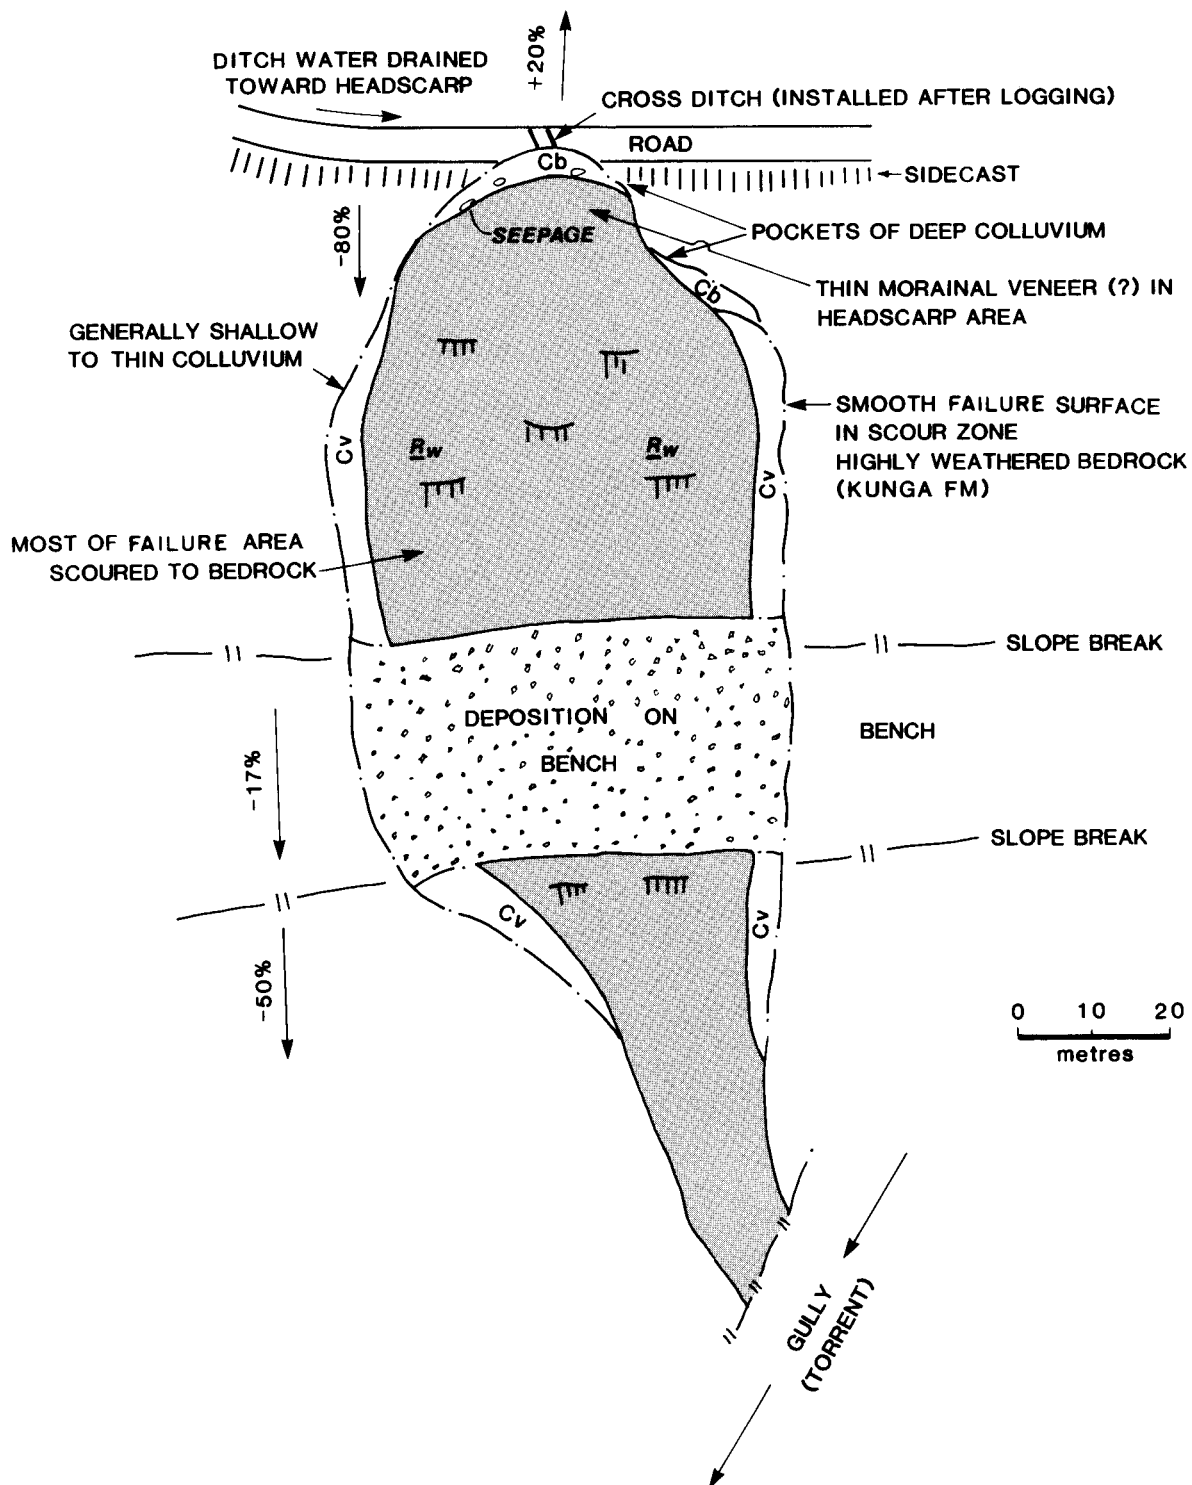
FIGURE A4.4. Sketch of Example #4, Bonanza Creek.
(Failure #1, BL 81059-142/143)

As in Example #3, both construction technique and road drainage contributed to this failure. The road was built on the edge of a major slope break, and waste material was sidecast onto the steep slope below, overloading the slope. Ditch water was then diverted onto the fill slope by a cross-ditch, saturating the fill and eventually causing failure.

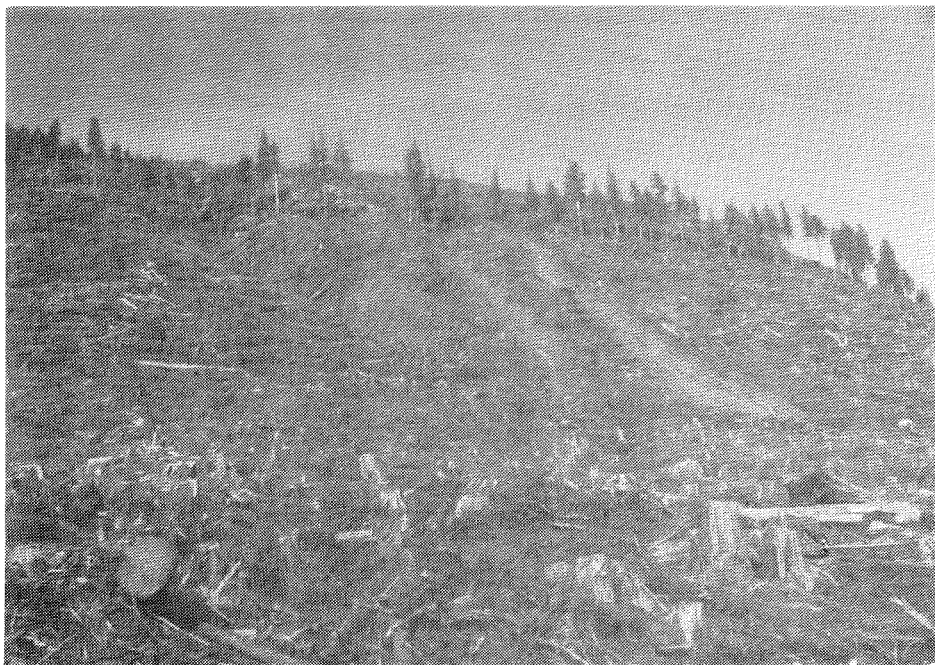
FIGURE A4.5b. Looking upslope to the three failures.

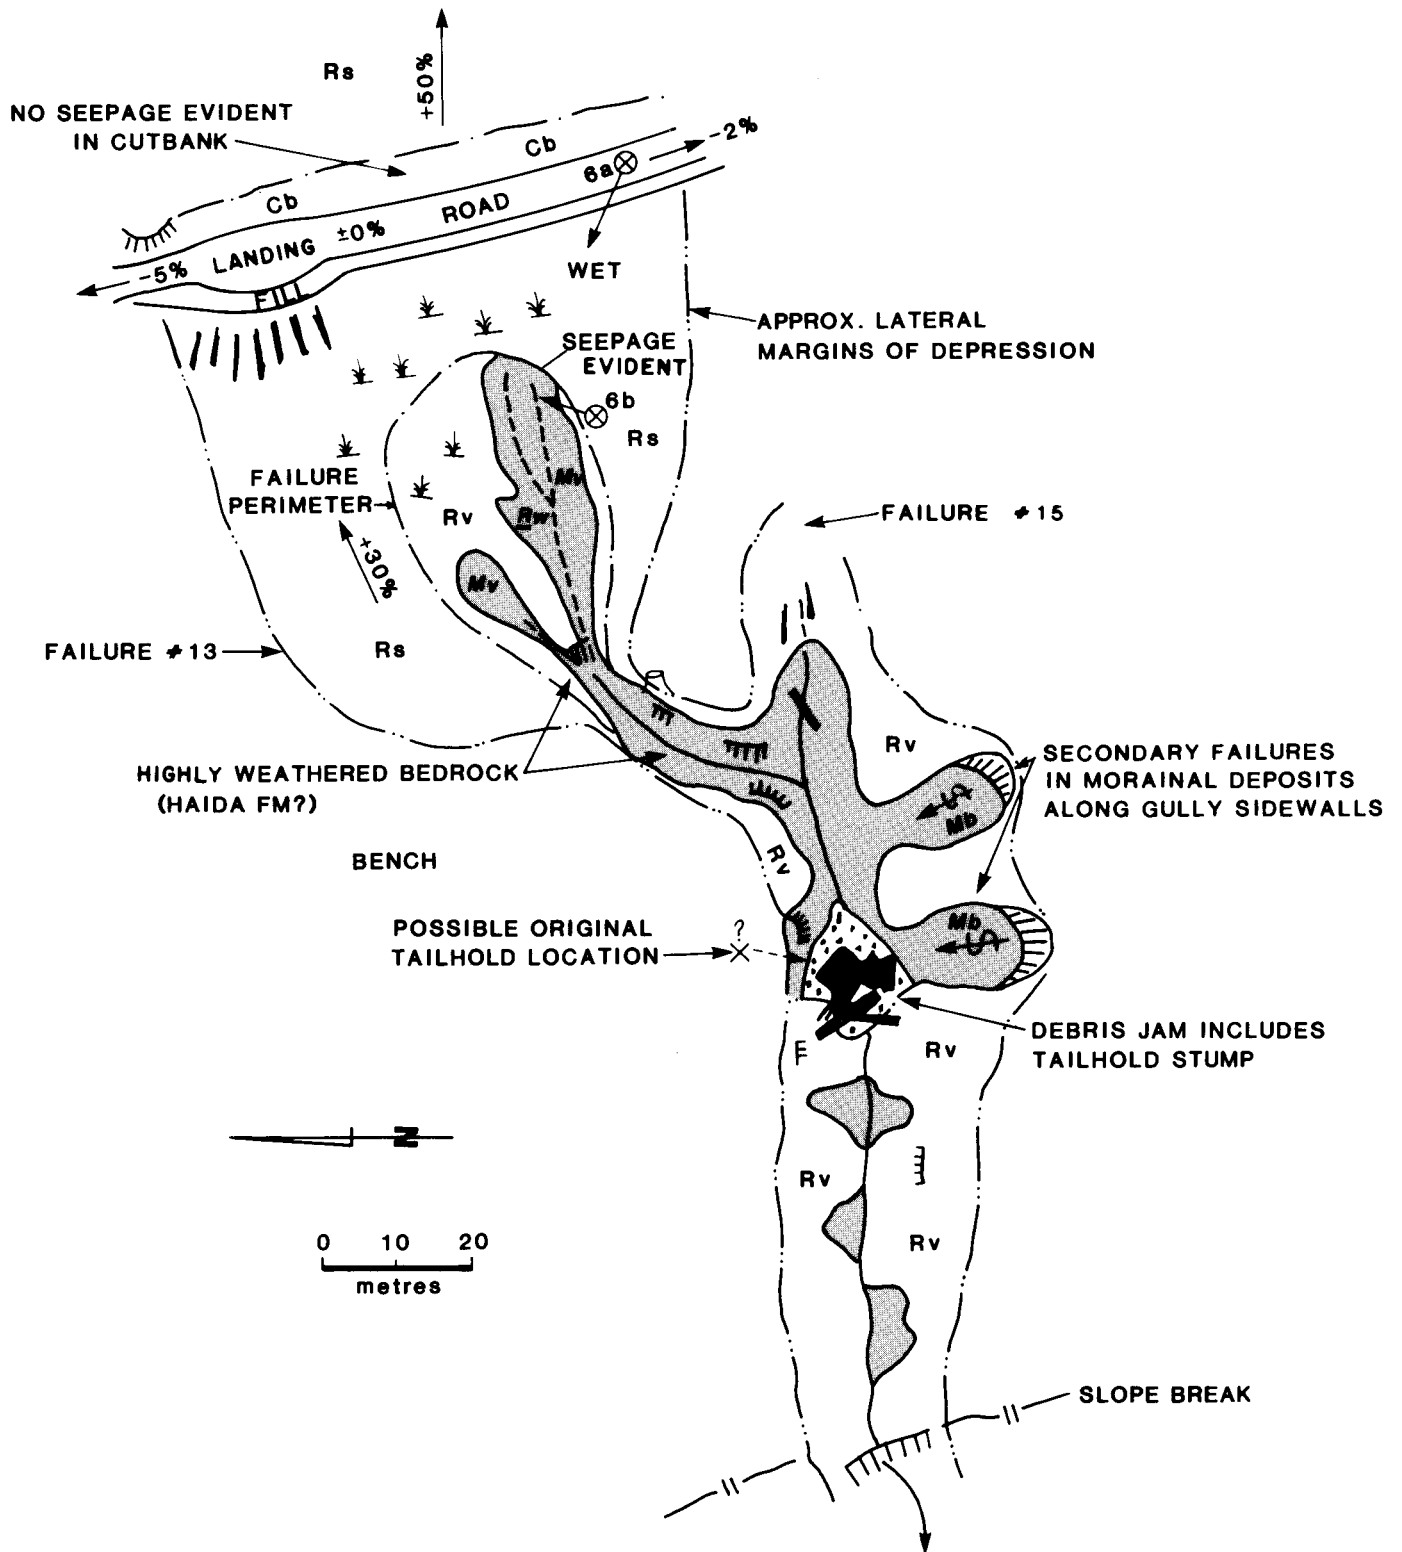
FIGURE A4.6. Sketch of Example #6, South Bay Dump Creek.
(Failure #13, FF8285-L13-116/115)

The shape of the failure conformed to that of the depression: wide at the (roughly) semicircular headscarp and narrow where it exited into the gully channel. Seepage was flowing out of the headscarp and continued as surface flow into the gully.

The road was built on the inside edge of the bench, about 20-30 m above the failure headscarp. It had a level to rolling grade and was built on a subgrade of colluvium excavated from the inside bank. No rock or morainal material was exposed on the cutbank within the depression area, although rock outcropped at the margins of the depression. The road section within the depression was not ditched. There was evidence that water occasionally flowed across the road, but mostly it seemed to pass through or under the ballast. As the road dropped away to either side, additional water was not diverted into the depression.

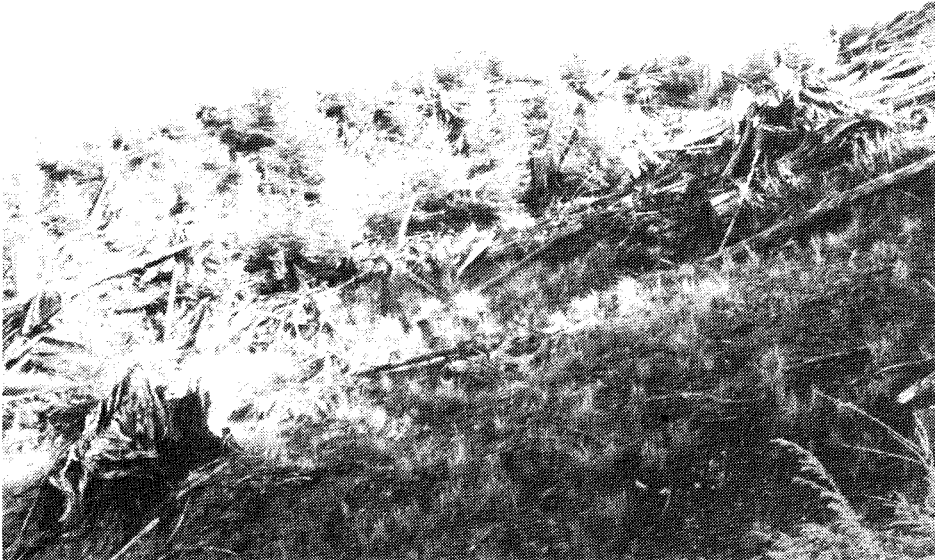
FIGURE A4.6a. Bowl-shaped depression below road (the slide area is light yellow, covered with grasses and sedges), Example #6.

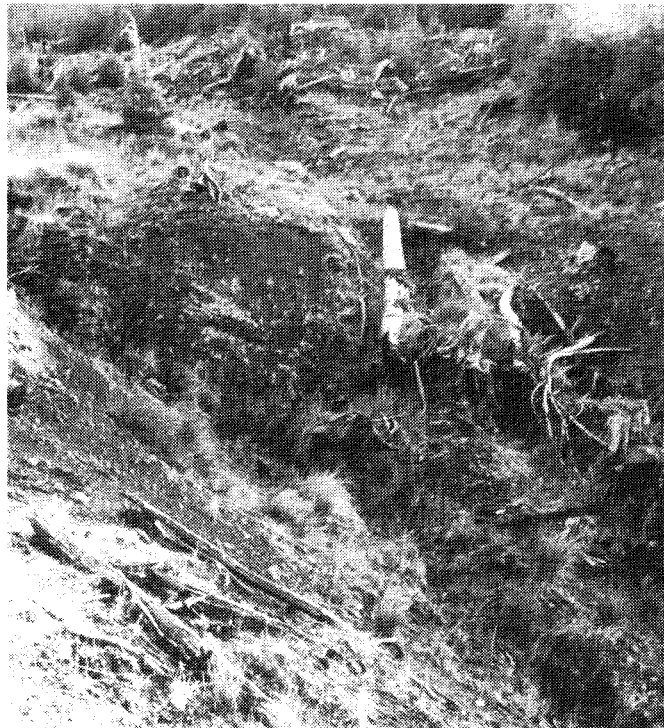
FIGURE A4.6b. Headscarp area of Example #6.

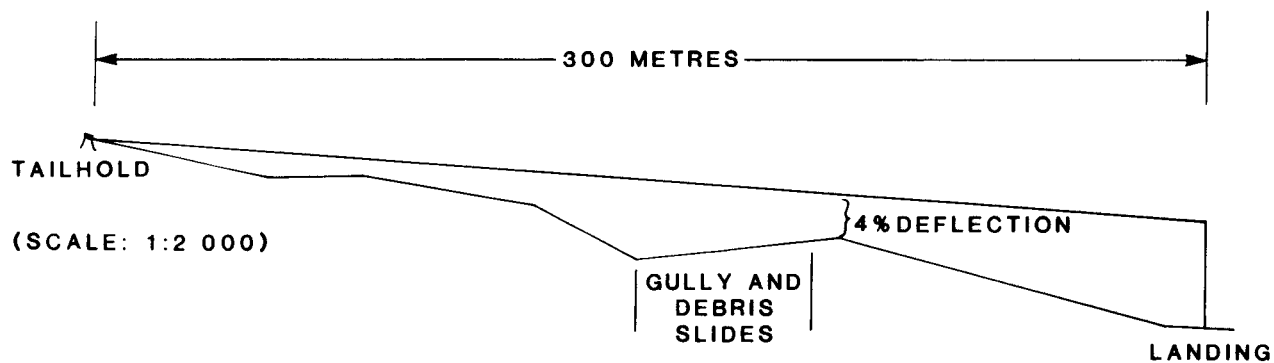
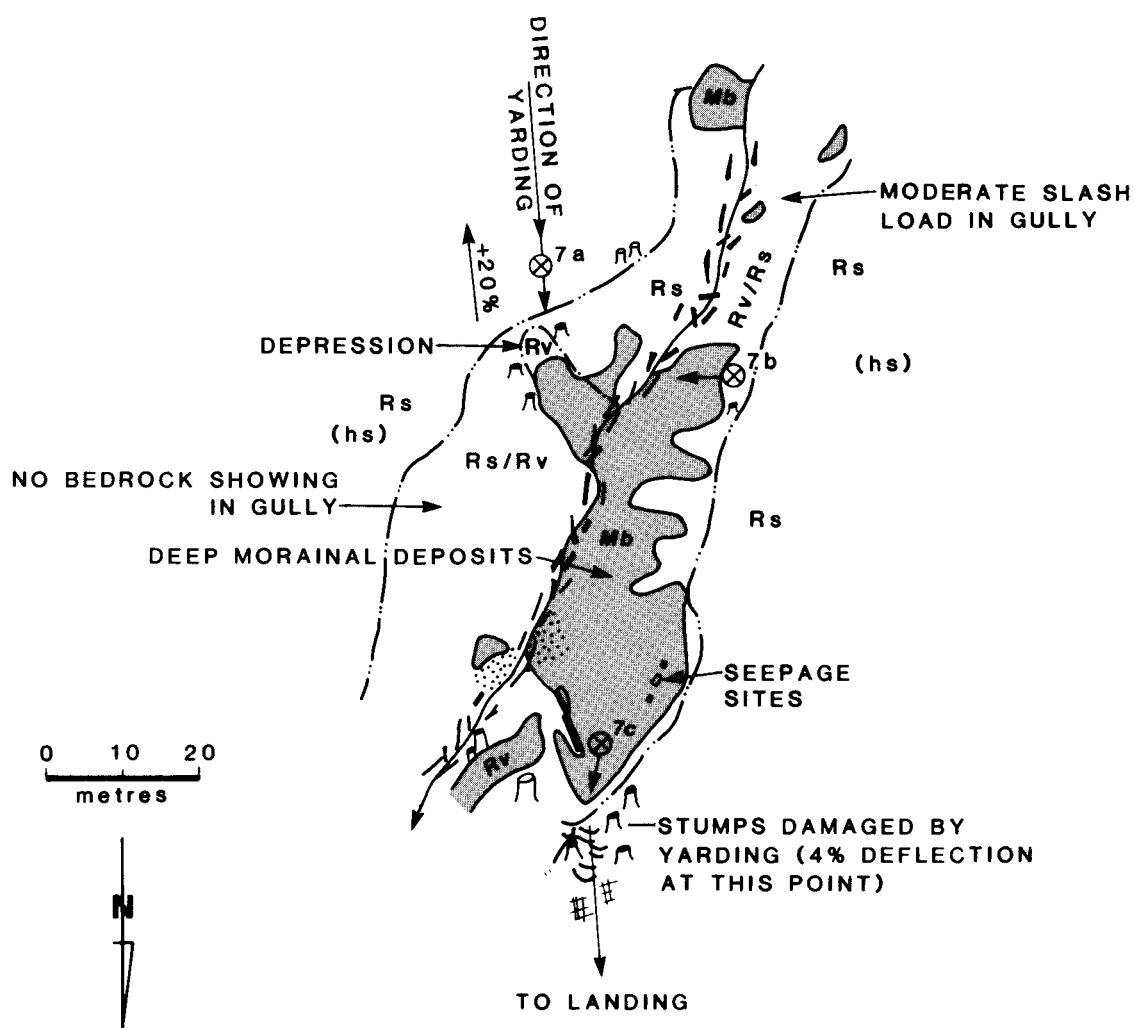
FIGURE A4.7. Example #7, Sach's Creek

Two logging-related factors account for the extensive scarring and consequent mass wasting in this gully: 1) several yarding roads crossed the gully; and 2) deflection was poor.

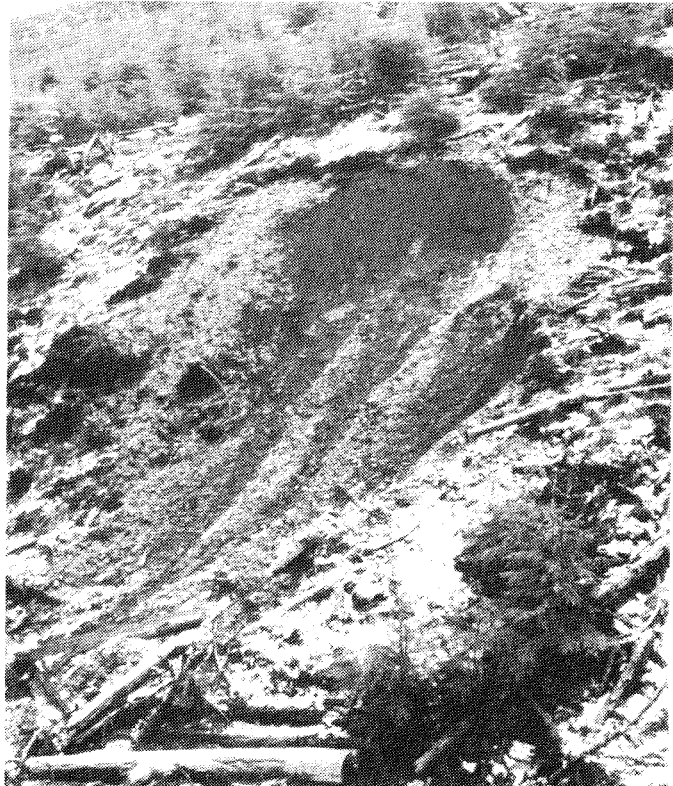
FIGURE A4.7b. Small failure on east sidewall, Example #7.

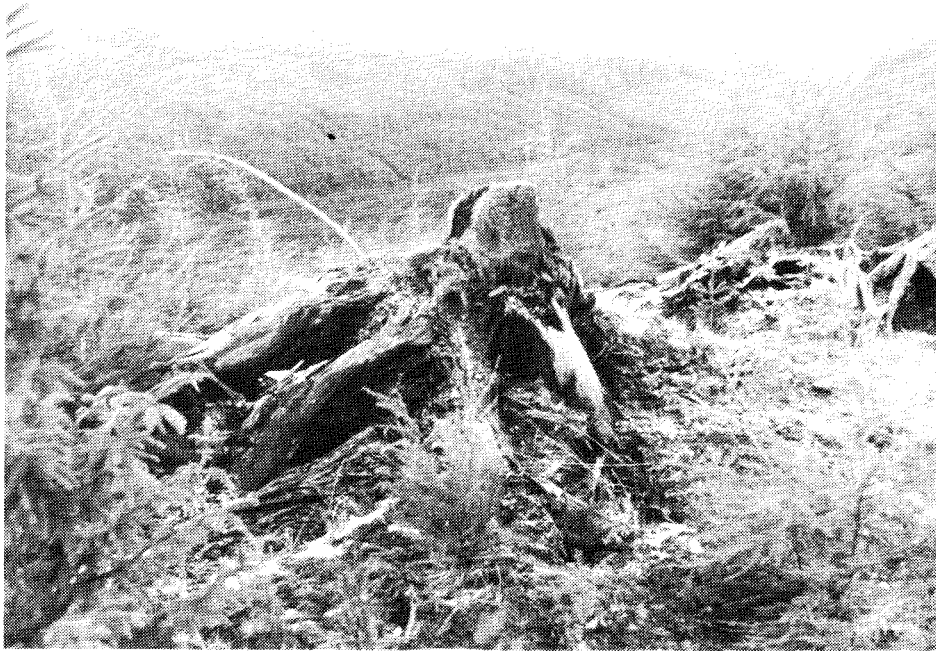
FIGURE A4.7c. A stump on the west sidewall damaged by yarding, Example #7.

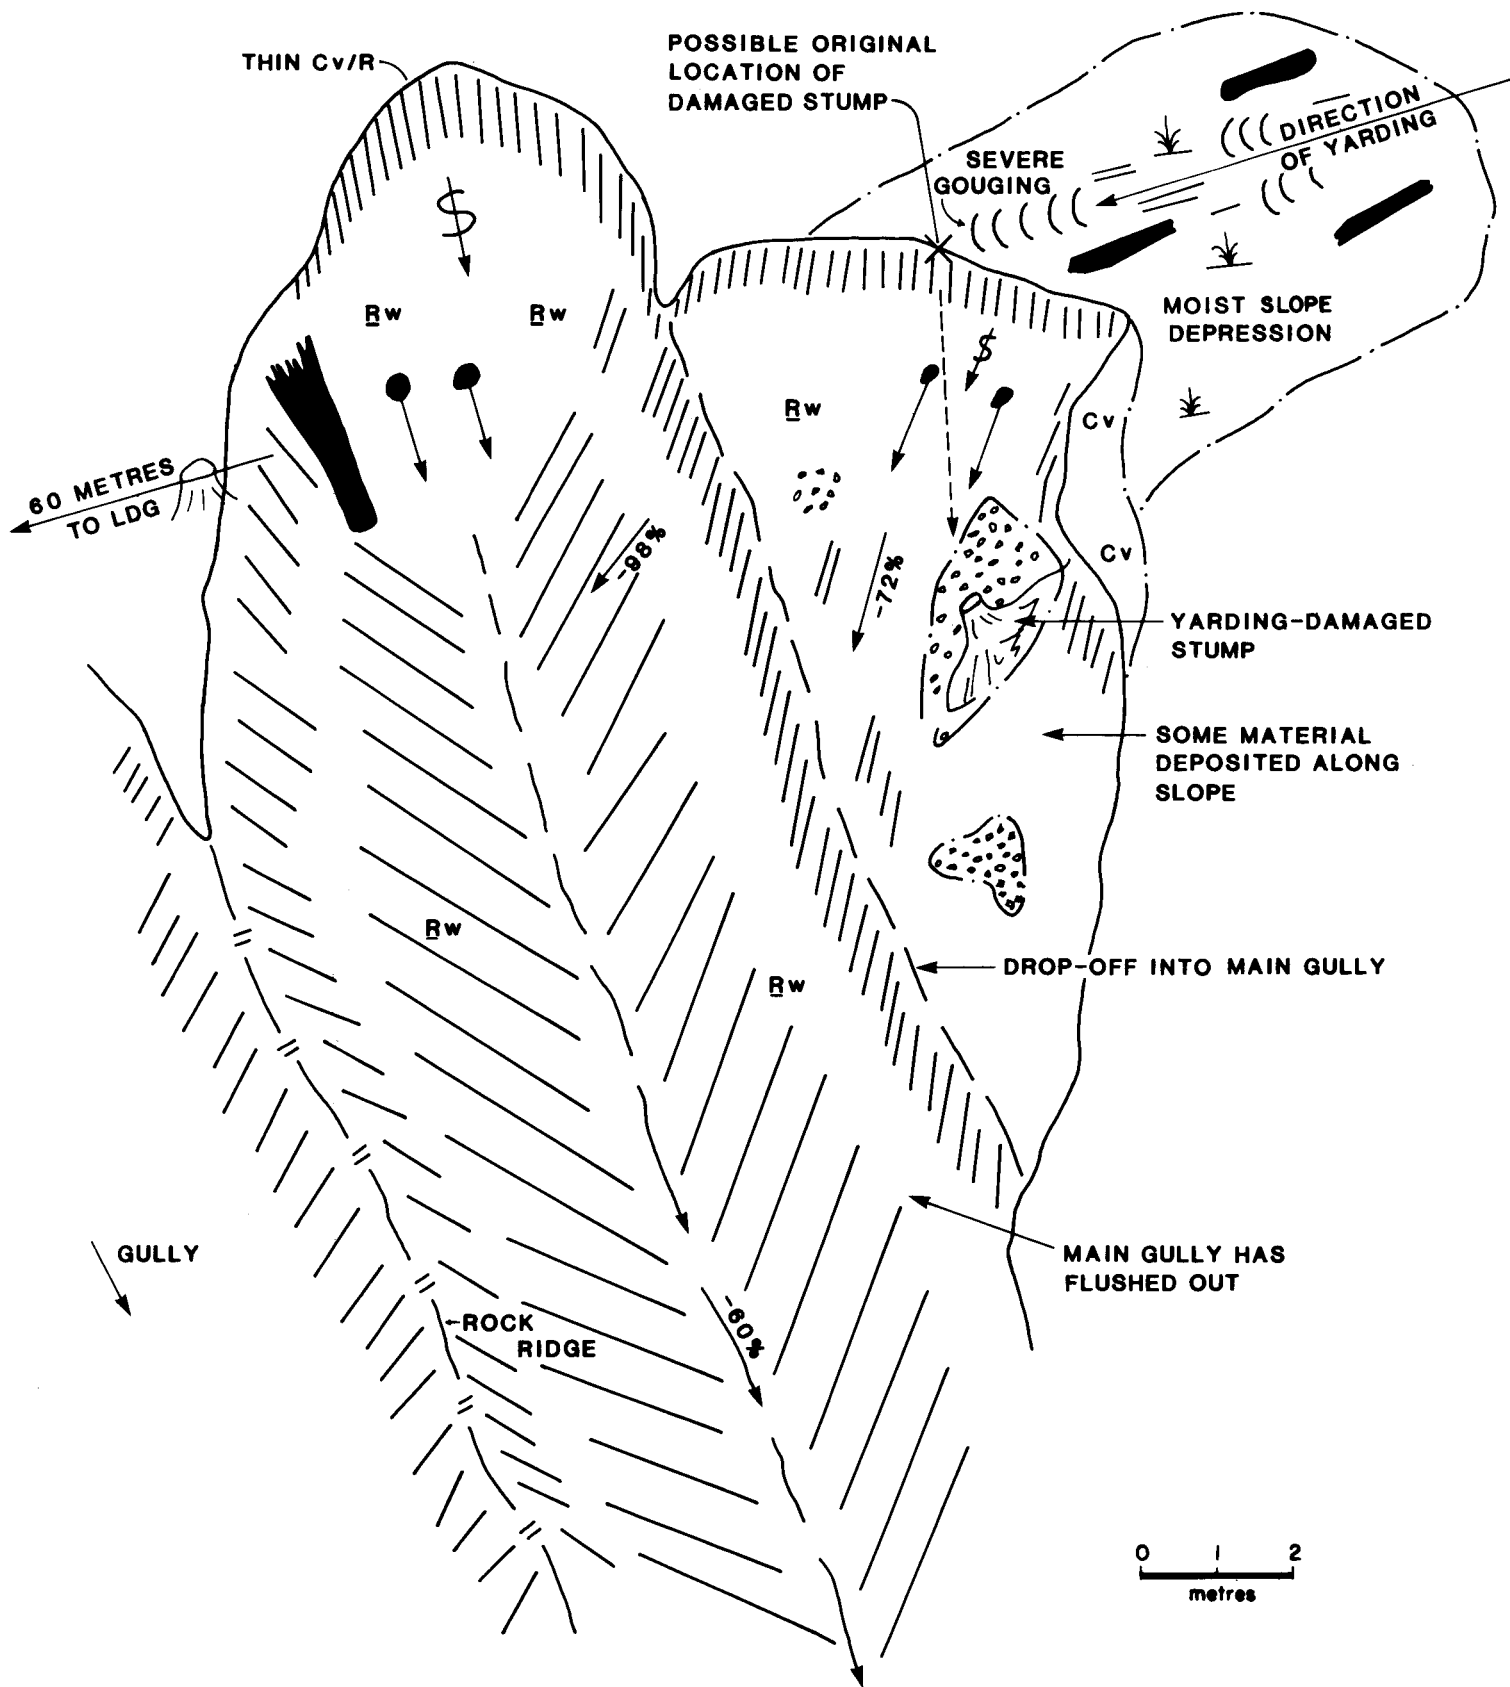
FIGURE A4.8. Example #8, Riley Creek.

The failure occurred sometime after logging and therefore was not triggered by yarding. This failure might have occurred even if the area had not been disturbed, but severe yarding disturbance could have accelerated it, perhaps by damaging root systems and loosening the soil mass.

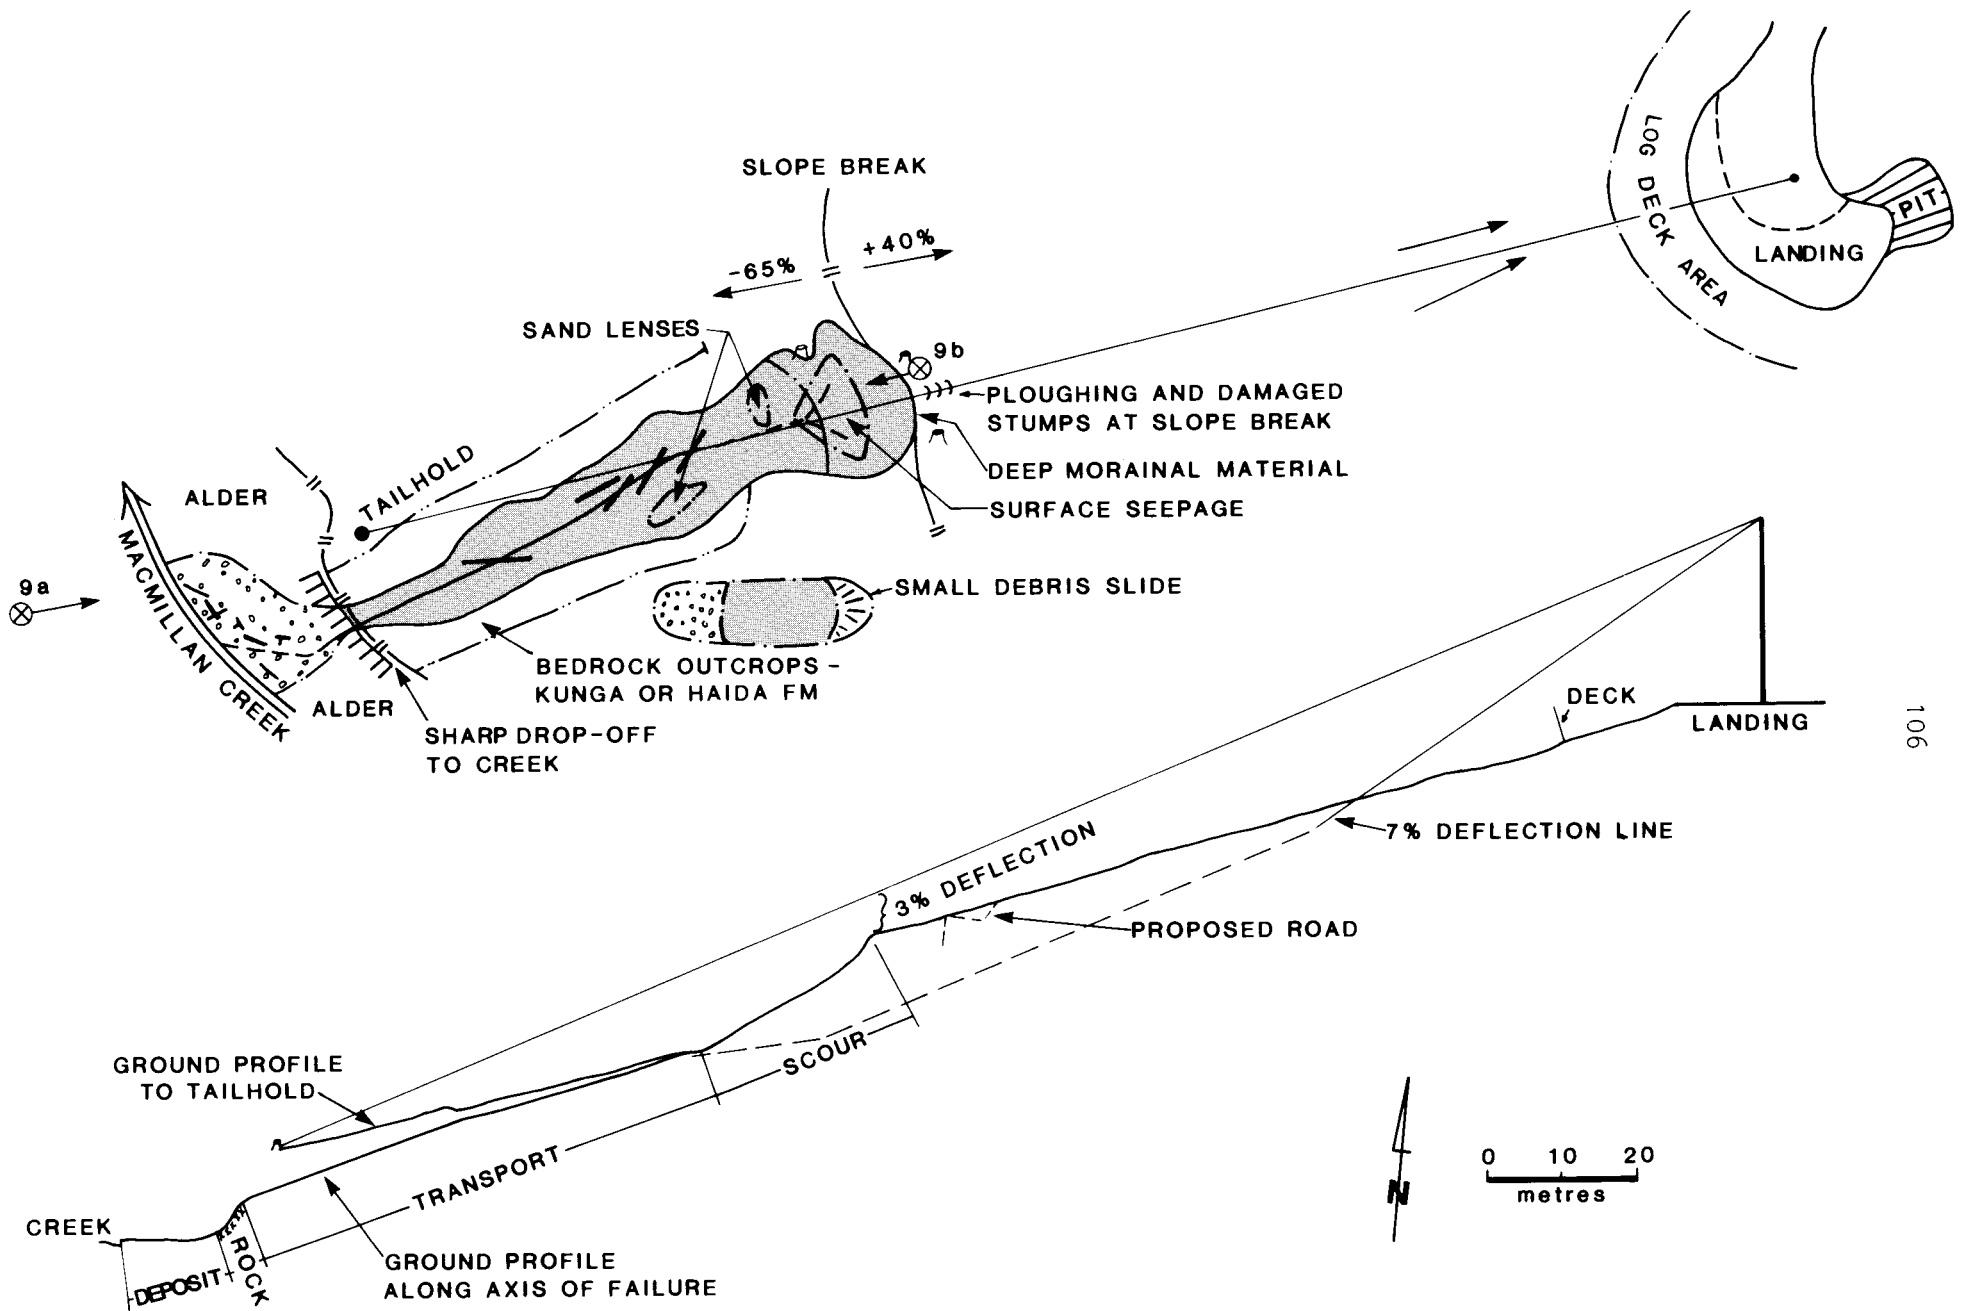
FIGURE A4.9. Example #9, MacMillan Creek.

A noticeable break in slope across the sidehill, at the same elevation as the headwall, produced a convex slope into the gully. The failure originated at this break. The average sideslope was 40% above the break and 65% below it. The area was generally depressional and received seepage from the uniform slope above, which flowed out of the headscarp along the top of the till layer.

Minor gouging was visible on the slope break above the gully headwall, but yarding disturbance may have been severe below the break. Deflection was very poor over the entire length of the gully. As Figure A4.9 shows, the yarding direction was nearly parallel to the long axis of the gully and a yarding road extended up the channel and through the middle of the headwall. A stump-rigged tailhold was located at the top of the gully sidewall. There was no ground clearance on the back third of the yarding road. At the headwall area, in the middle third of the yarding road, clearance between the chord and the ground was only about 6 m, yielding only 3% deflection. This would not have been sufficient to lift the front end of logs clear of the ground, so ground-lead conditions must have prevailed at the headwall. Although the evidence was lost with the slide, this probably caused severe scraping and gouging on the steep slope below the break.

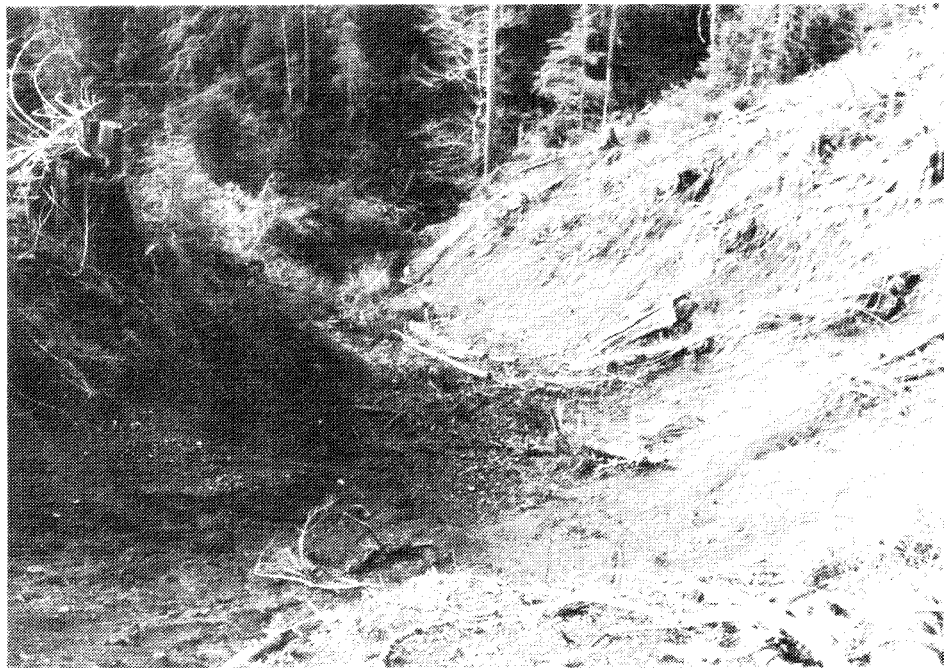
FIGURE A4.9b. Looking down the slide scar from the headscarp, Example #9.
