A Forest Engineering Analysis of Landslides in Logged Areas on the Queen Charlotte Islands, British Columbia

by
R.K. Krag,
E.A. Sauder,
and G.V. Wellburn

August 1986

FERIC Special Report SR-39

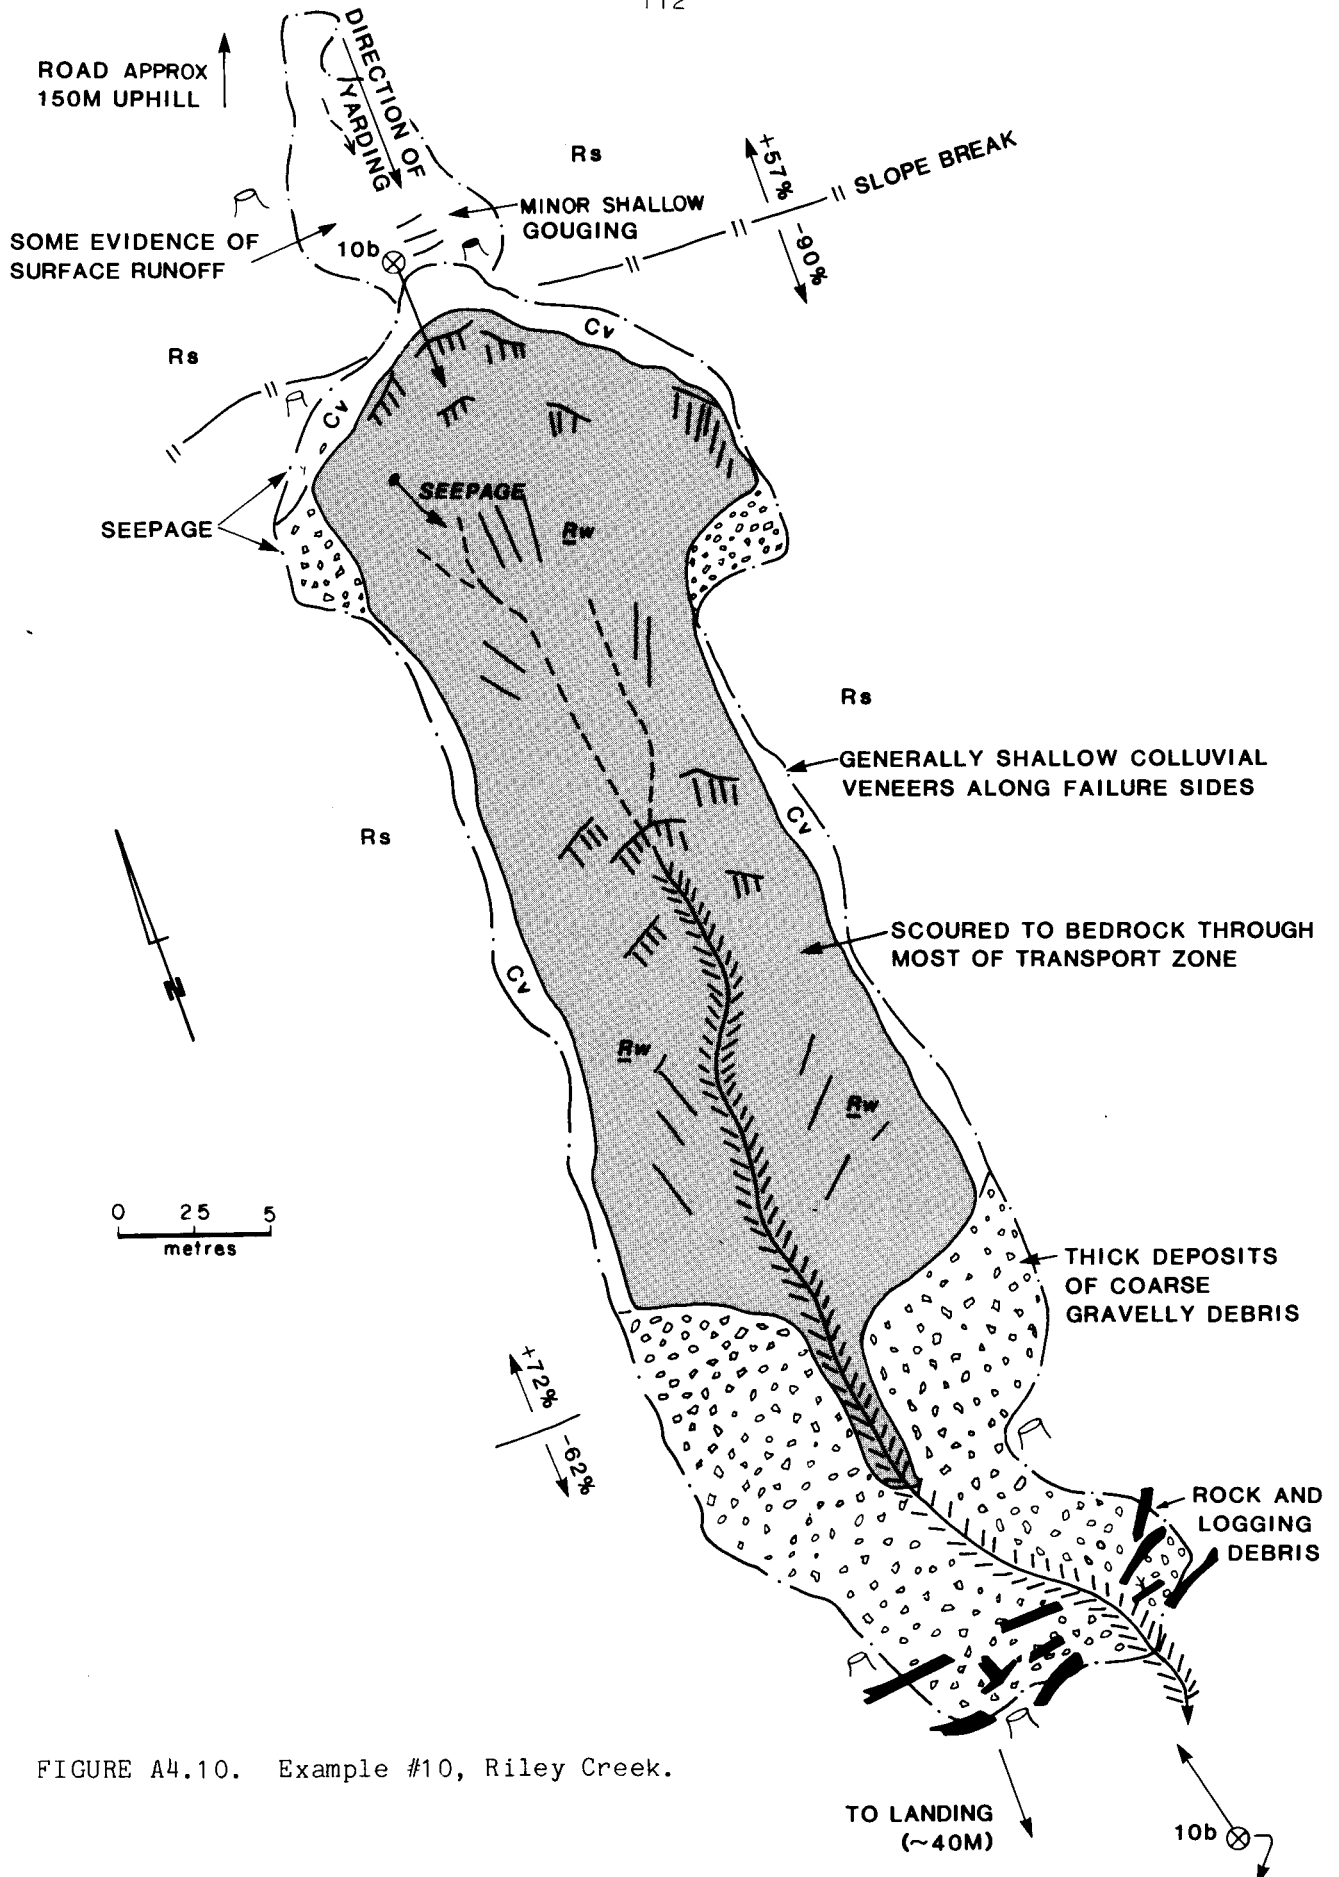
As the diagram shows, a yarding road crosses right through the slide initiation zone at an acute angle to the slide axis. Several scarred stumps were found above the initiation zone. The landing was about 100 m downhill (Figure A4.10b). Although a deflection line was not run, it was clear that deflection was poor above the slope break.

The presence of yarding disturbance in the headscarp area suggests that yarding, while probably not the triggering event, weakened a marginally stable site. Logs dragged through the site may have dislodged stumps located in the initiation zone. Unlike the earlier examples, however, disturbance did not appear to be very severe.

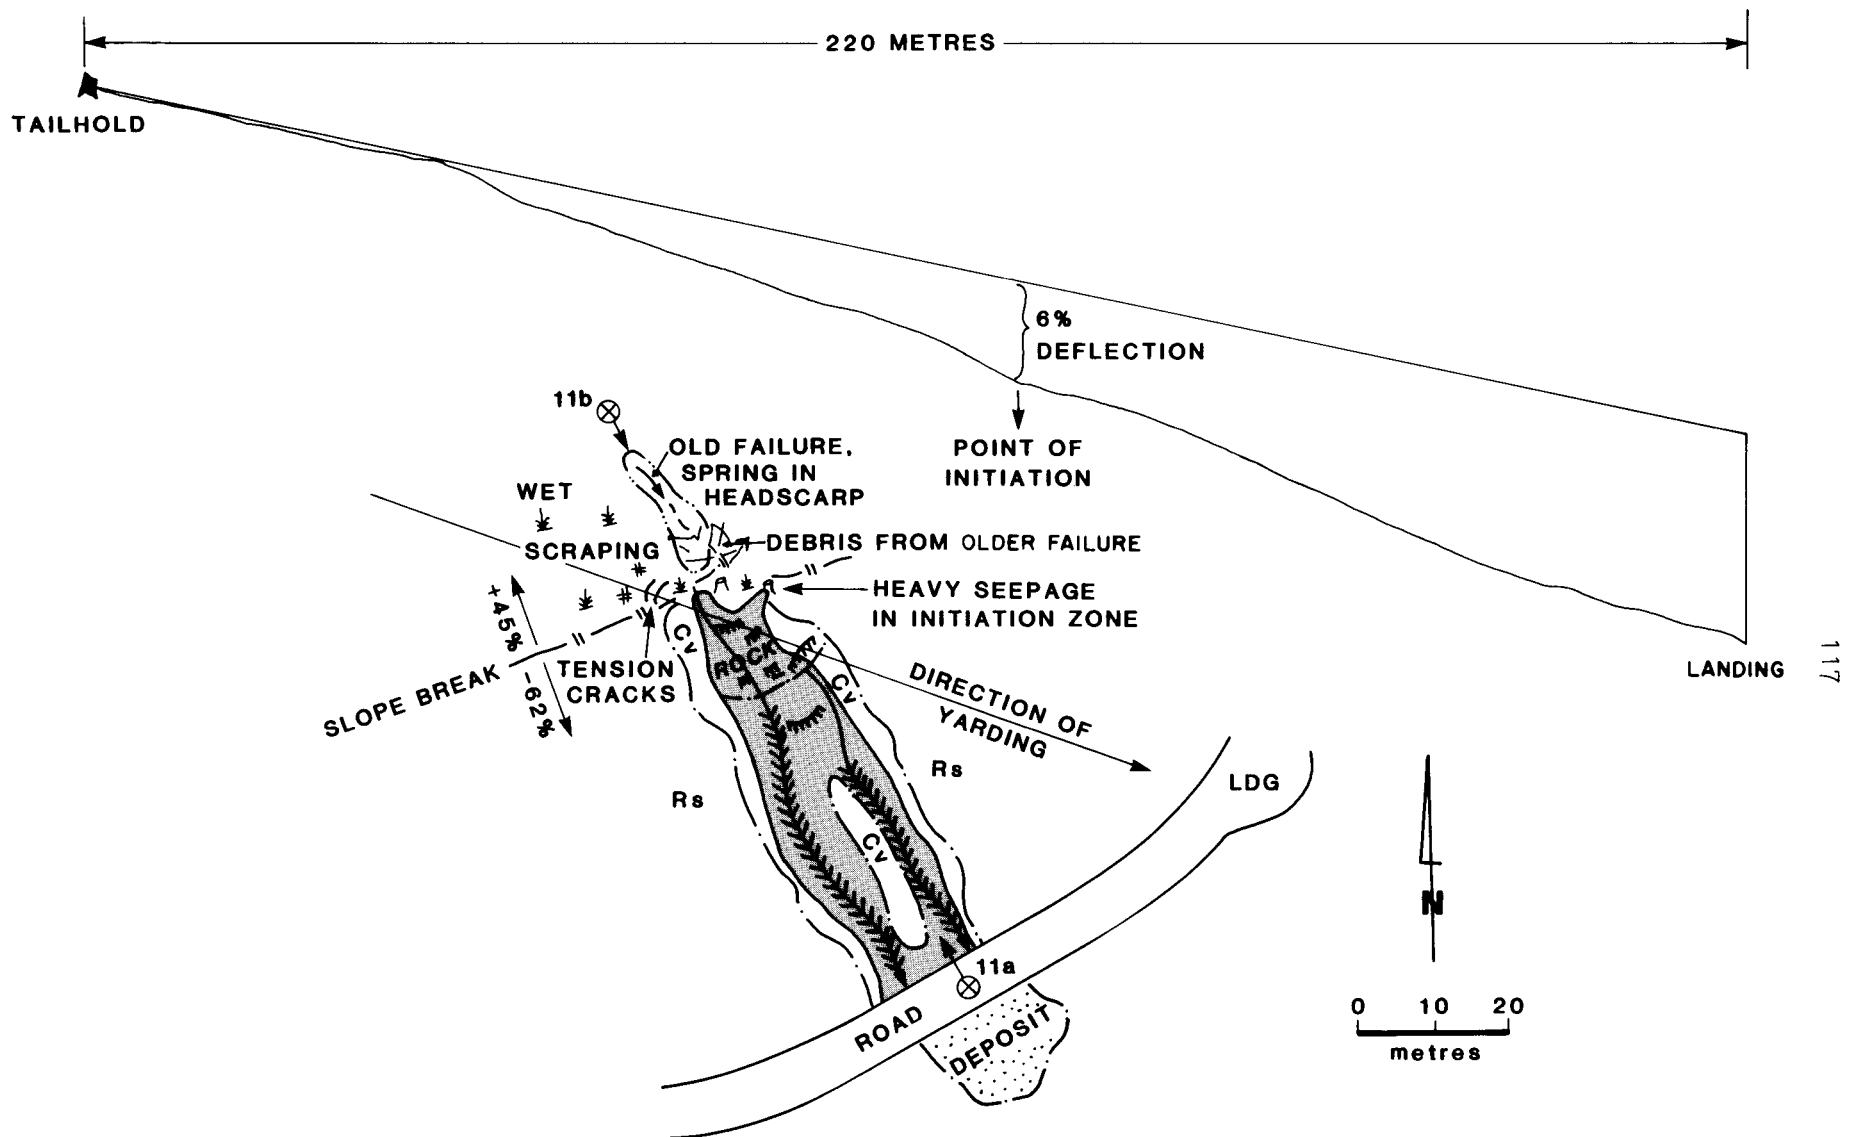
FIGURE A4.11. Example #11, Haans Creek.

The recent failure is known to have occurred in August 1983, several years after the area had been logged. The previous failure occurred before the area was logged, shown by the way fallen trees had been bucked. A yarding road passed through the initiation zone of the new failure at about 45° to the long axis of the landslide, resulting in scraping and gouging down to the surface of the weathered bedrock. Yarding direction was downhill.

The ground profile along the yarding road shows that deflection was fair in the headscarp area (see Figure A4.11). Clearance between the chord and the ground was 13 m, giving about 6% deflection. The profile, viewed along the yarding road, indicates there was not an abrupt change of slope at this point because the yarding road crossed the slope break at an angle.

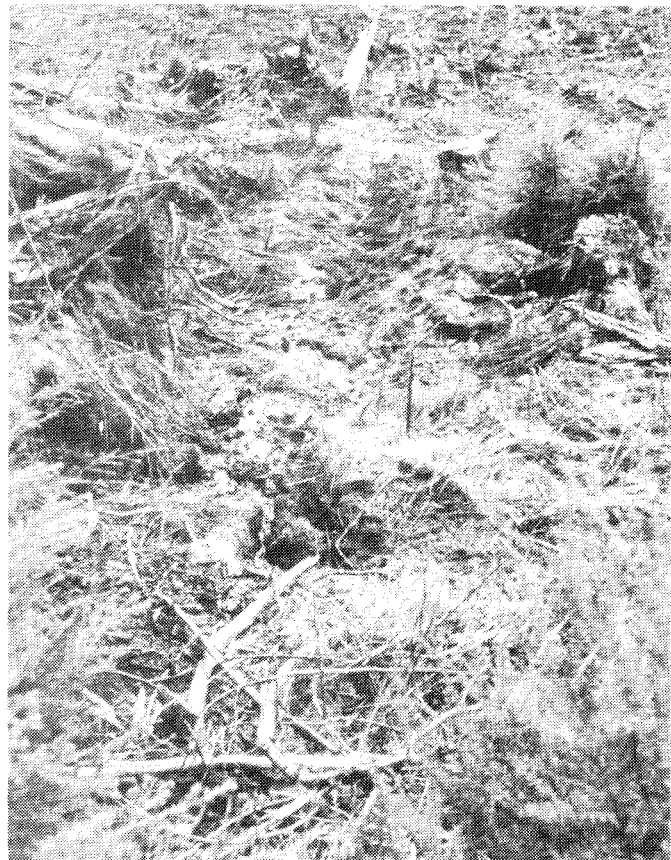
FIGURE A4.11b. Looking down the small older failure above Example #11. The new failure (not visible) initiated just below the deposition zone of this failure.

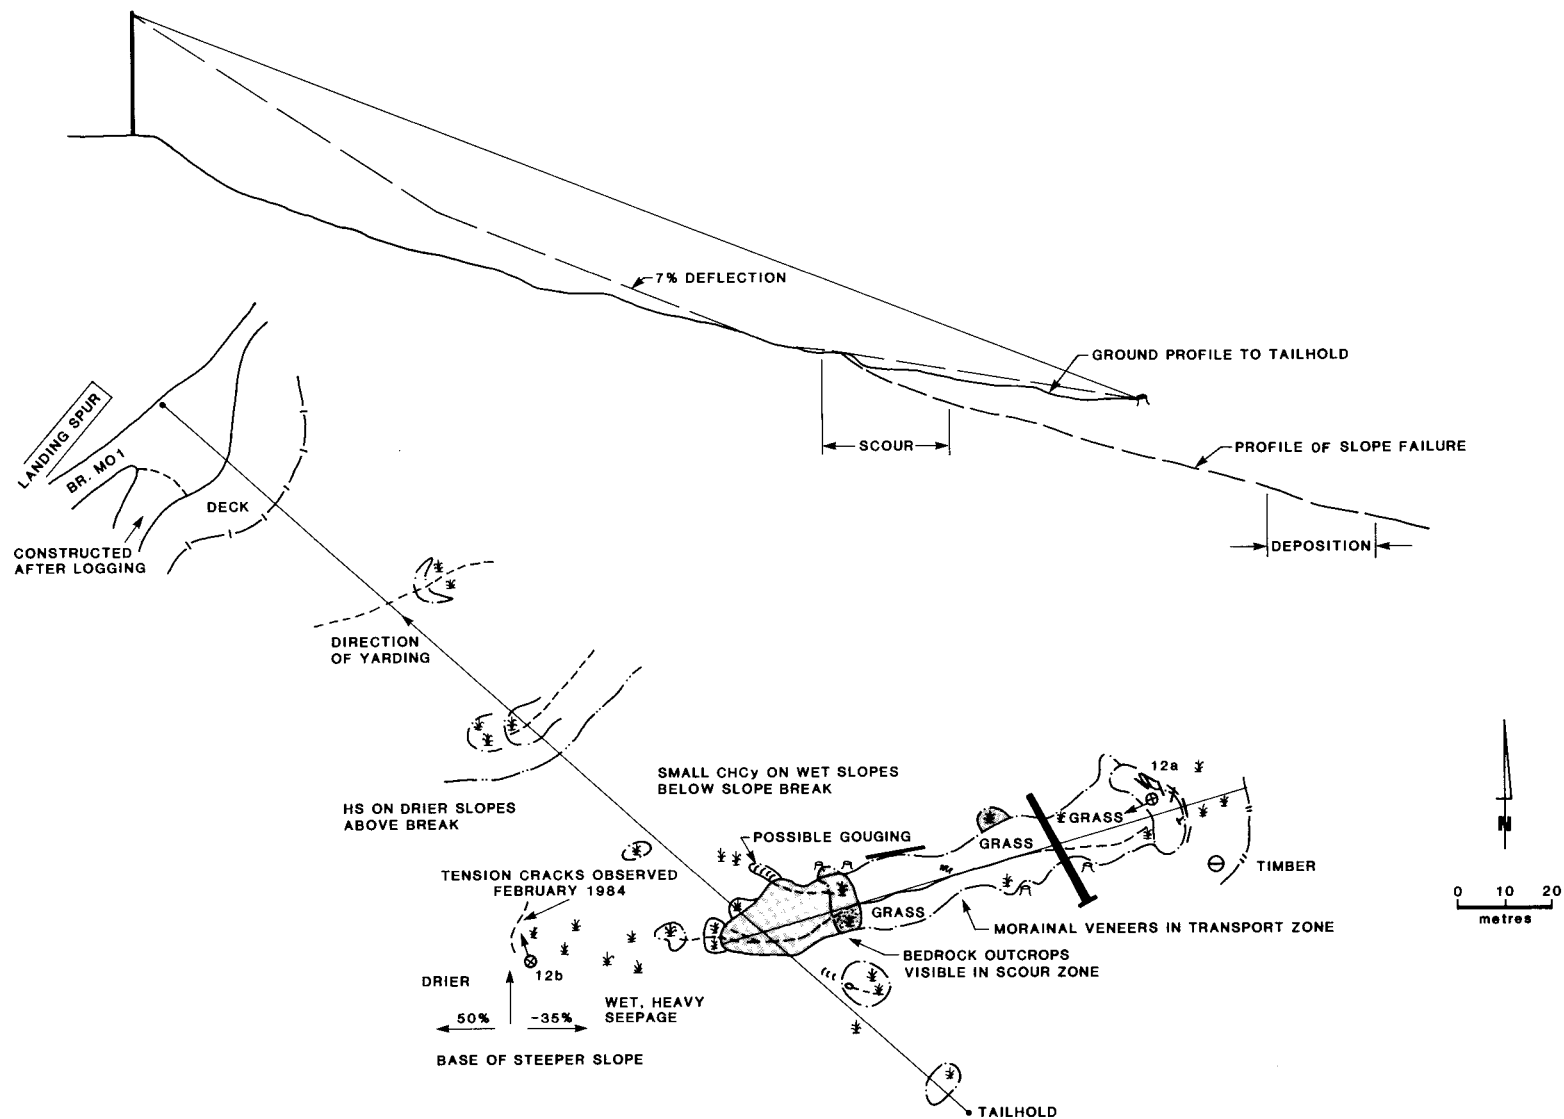
FIGURE A4.12. Example #12, MacMillan Creek.

As Figure A4.12 shows, a yarding road crossed the failure about 15 m downslope of the initiation zone, but, except for one small gouge, there was no evidence of yarding disturbance. Nor were the lateral margins of the slope depression scarred. The yarding direction was predominantly cross-slope and uphill, which--combined with fair to good deflection (7% where the yarding road crossed the scour zone)--should have provided a favourable lead for yarding logs. Also, only a few turns would have been yarded over the failure site, because it was in the back third of the yarding road.

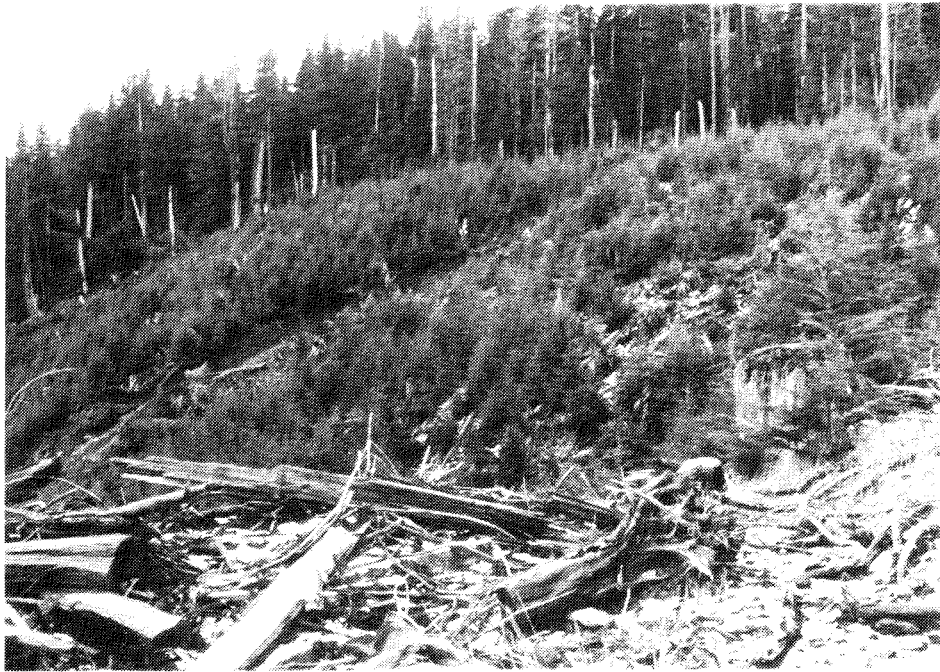
The failure began in a slope depression that extended up to the slope break and beyond. An old slide scar was visible above the initiation zone of this failure. A small amount of surface flow was evident above the headscarp 2-3 weeks after the failure had occurred, and subsurface seepage was heavy. When inspected in February 1984, seepage was flowing out of the initiation zone and along the rock surface. Despite the apparent wetness of the area, water flow in the gully was small. A nearby gully, which did not fail, had a substantially greater flow.

FIGURE A4.13a. Looking across the clearcut to the initiation zone of Example #13.

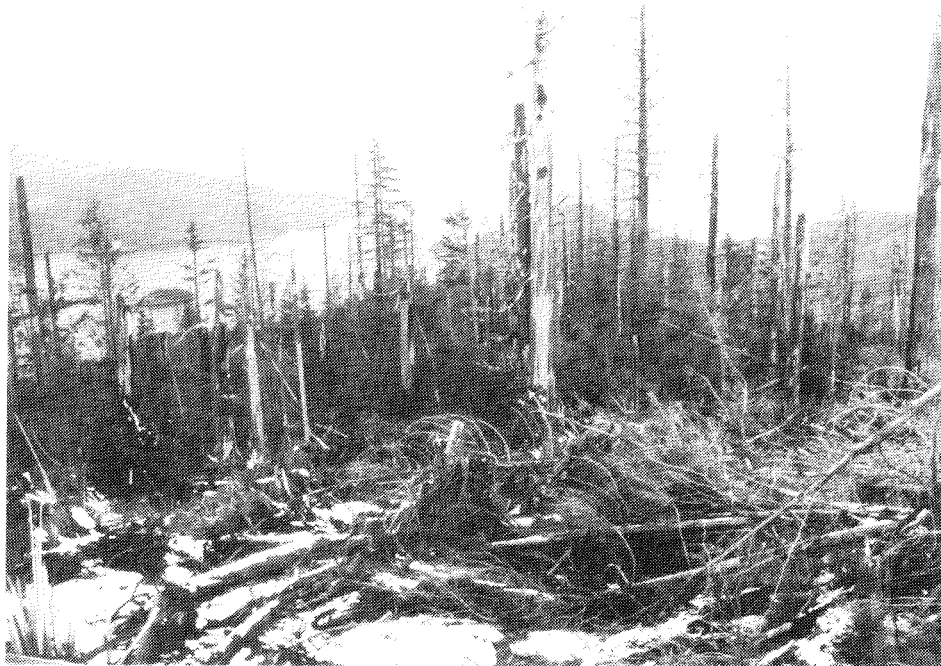
FIGURE A4.14b. Decadent insect- and wind-damaged stand in the initiation zone of Example #14.

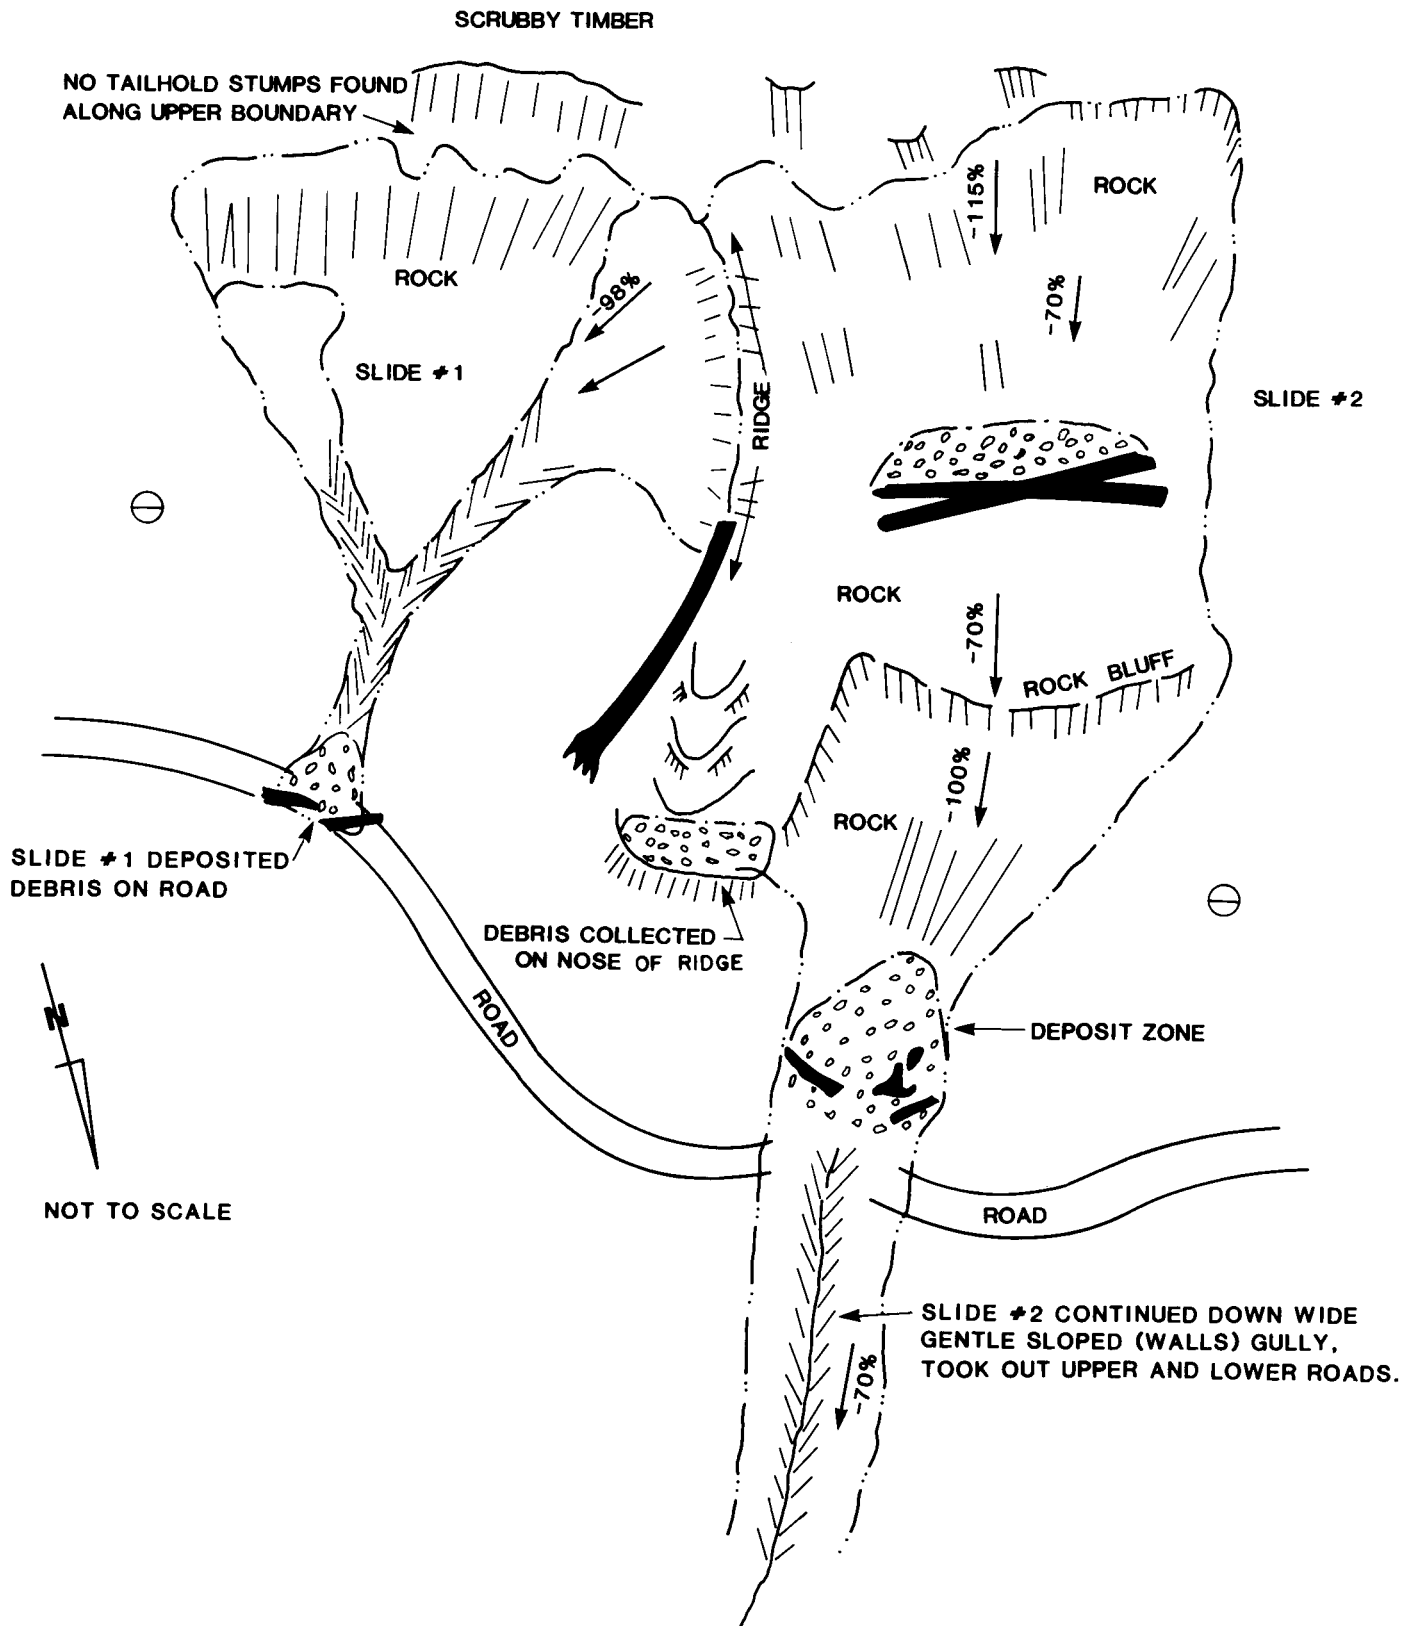
FIGURE A4.15. Example #15, Talunkwan Island

There was no evidence to suggest that yarding was particularly difficult near the clearcut boundary, but the failures might have removed any signs that were present. Tailhold stumps may have been pulled out or loosened during logging. Windfall at the upper boundary was slight and did not seem to be a factor in these failures. However, the failures are believed to have occurred several years after logging, so root deterioration is a possible logging-related factor, in combination with steep slopes and perhaps other factors.
