June 1979 Technical Report TR-31

TRIAL OF ÖSA 670 FELLER BUNCHER AND ÖSA 705 PROCESSOR IN BRITISH COLUMBIA

L.H. Powell
G. St. Jean

**Technical Report No. TR-31
June 1979**

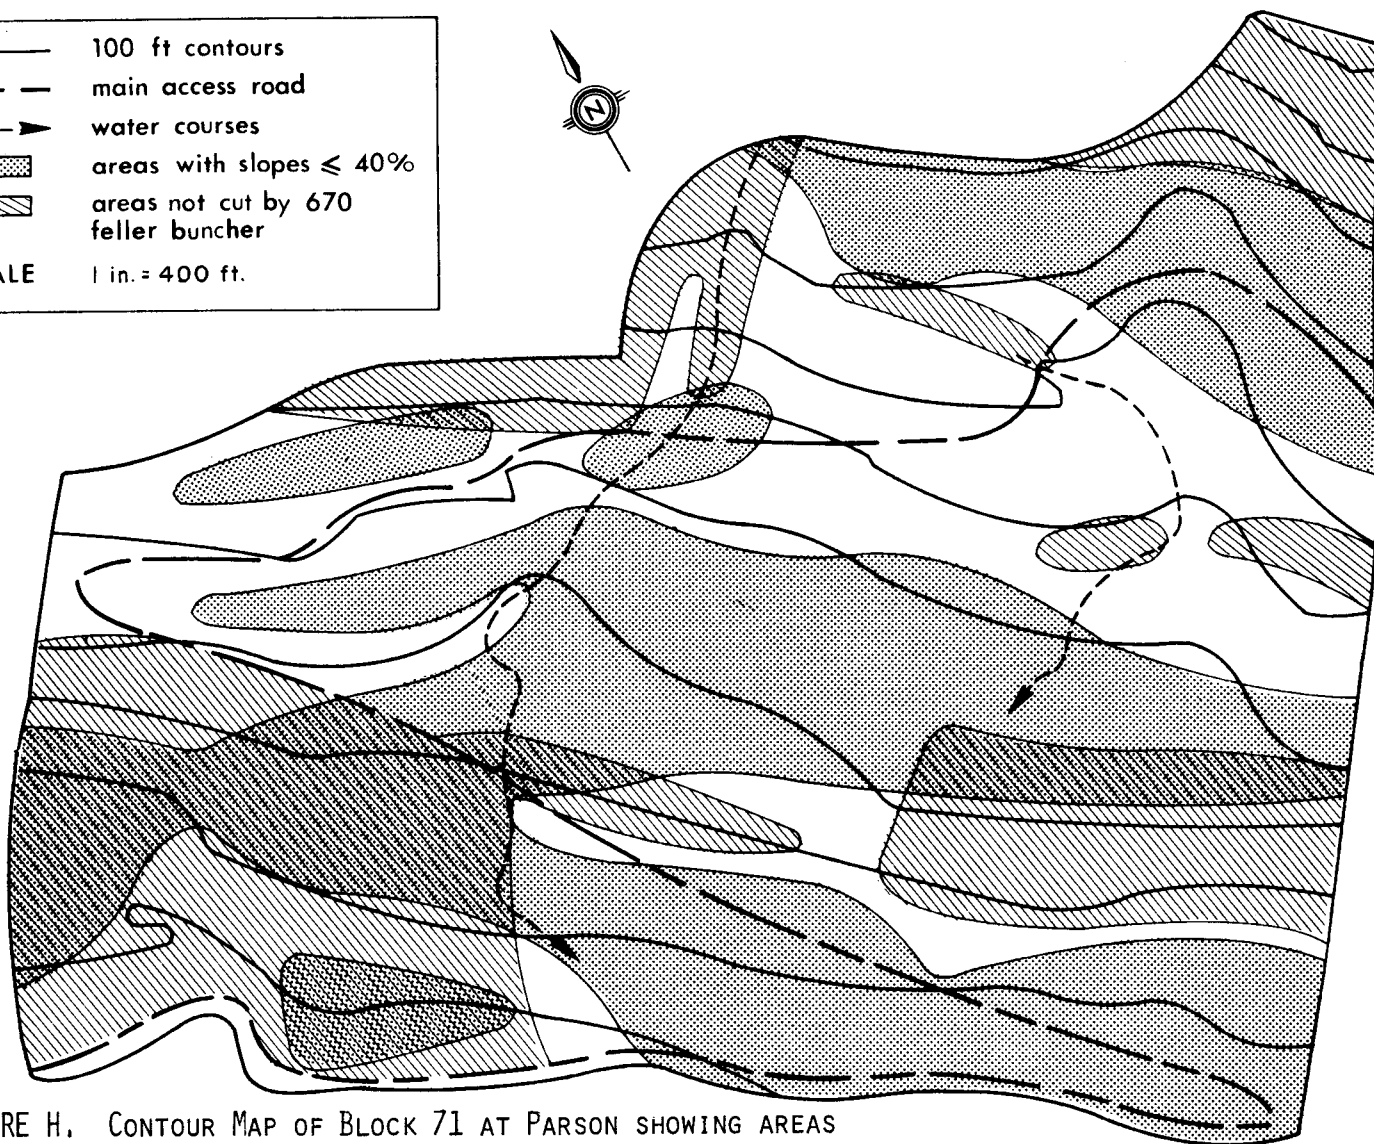
FIGURE H. CONTOUR MAP OF BLOCK 71 AT PARSON SHOWING AREAS (STIPPLED) MOST SUITABLE FOR THE FELLER BUNCHER TO HARVEST AND AREAS (HATCHED) NOT CUT BY THE FELLER BUNCHER.

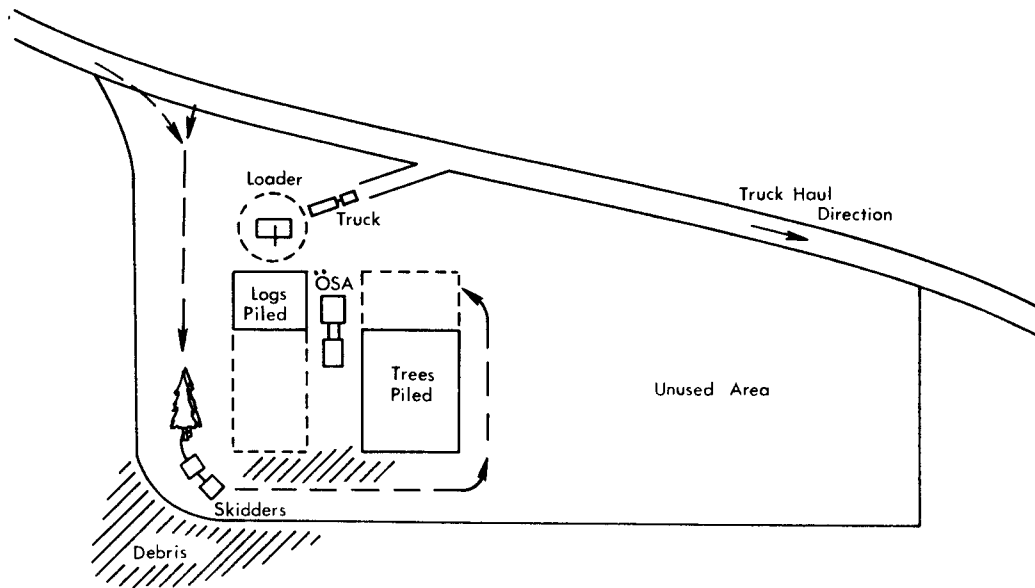
ACTUAL LAYOUT - POOR

Figure I. Layout of Landing at Parson. Layout is considered poor due to crowding of work into a small area with only one pile of trees for processing. Lack of enough road access to the landing limits area of use and causes congestion. This meant that the processor, skidders (as many as 5 at times), the loader and trucks were crowded into the same area, disrupting work and creating safety problems.

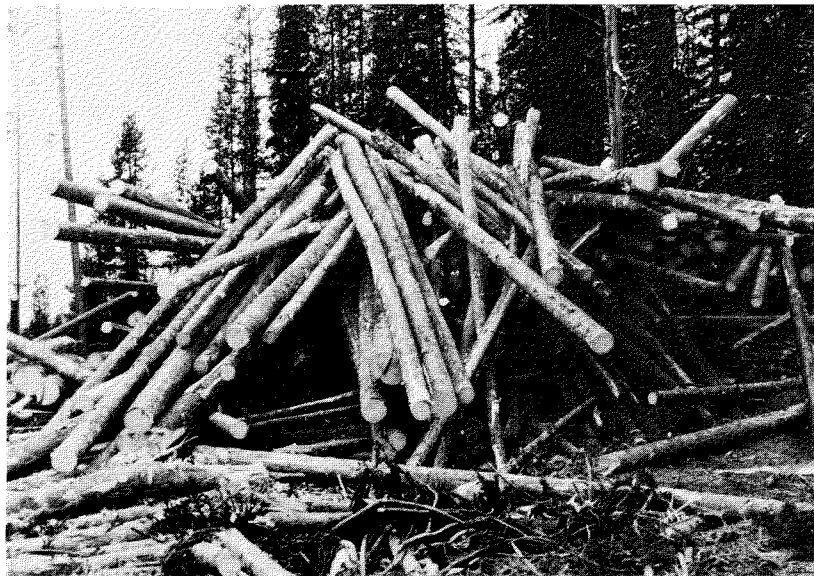
Figure L. Pile of processed logs after multiple passes in a congested landing. Limbing quality is excellent, but butt and top logs are mixed and piling quality is poor.
