Project No. 2166

**An Investigation into Chipped Surface
Quality Problems at Canter Lines**

Alan Wang and Gabor Szathmary
Wood Machining Scientist and Electronics Technologist
Lumber Manufacturing Department

September 2001

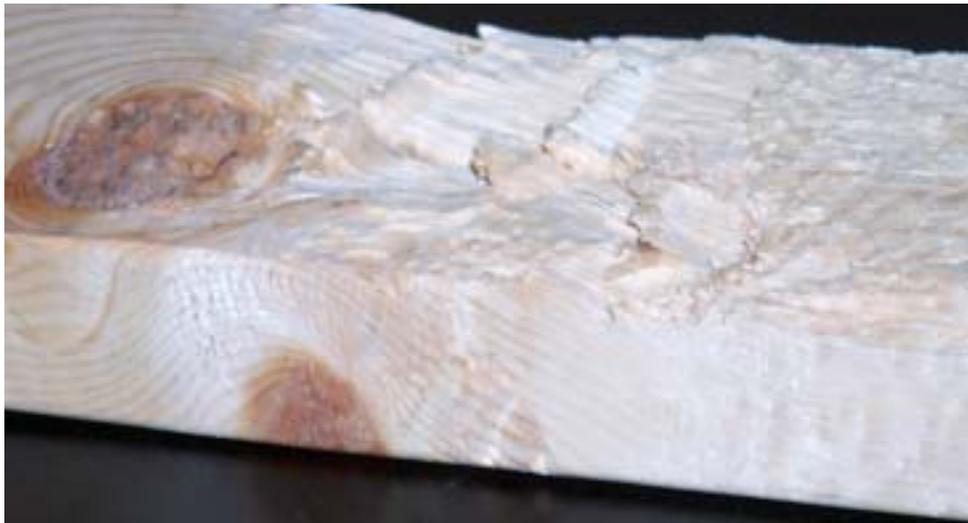
Figure 2 *Knot tear out*

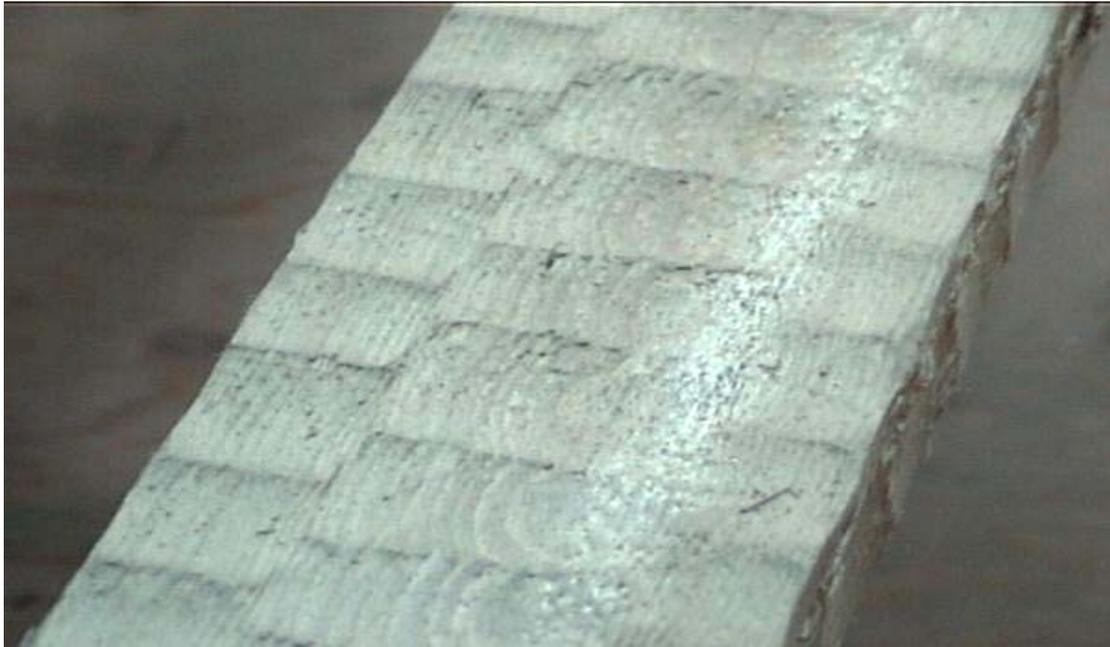
Figure 3 Typical chipped surface

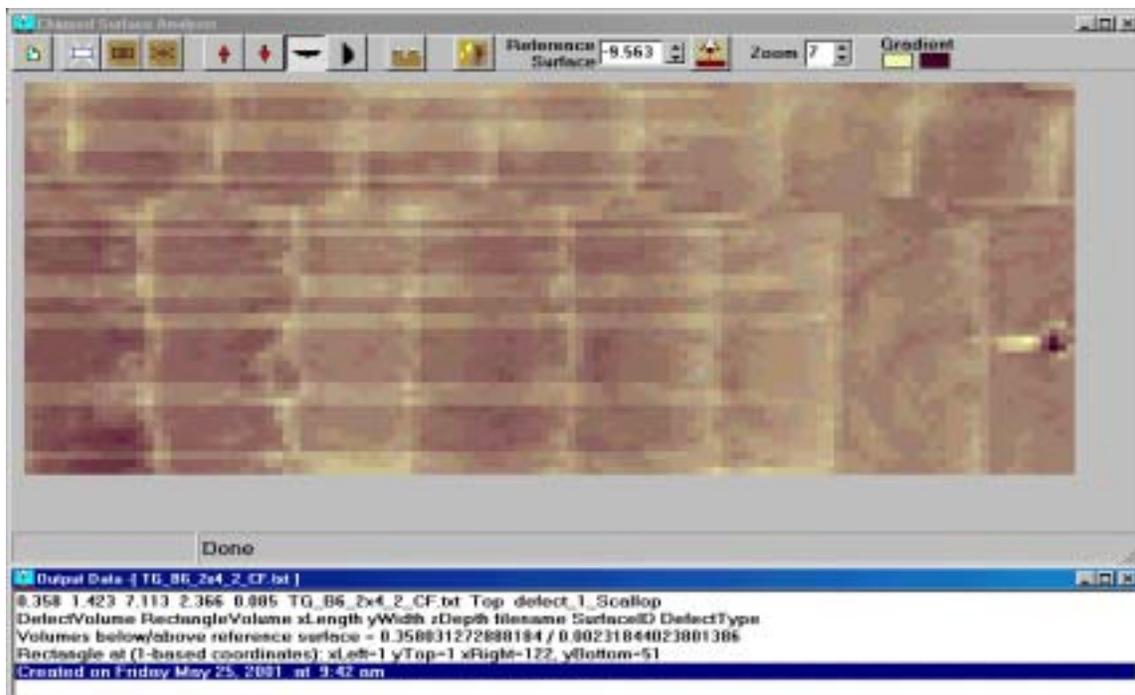
Figure 6 Scanner image showing scalloped surface

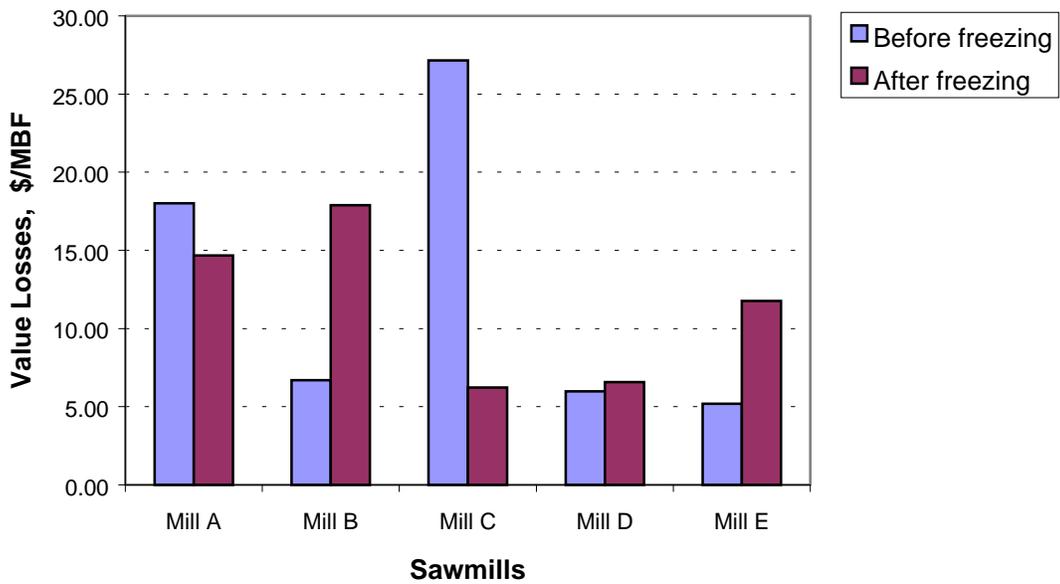
As one would expect the value losses and degrade percentages tend to be higher in freezing conditions and this was the case for mills B, D and E. Conversely, Mill C had the highest value losses and degrade percentages of any mill, and these were in non-freezing conditions (Figures 7 and 8). This is most likely due to the sampled lumber coming from logs that had been decked for some months before processing (see comments under Section 4.2 - Work Methodology). Mill A also had a higher value loss in non-freezing conditions, possibly due to:

For a sawmill with 100 MMBF/year, a value loss of \$ 5.0/MBF would cause \$ 500,000/year loss. The majority of the results (Figure 7) had values over \$ 5.0/MBF. Value losses tended to be higher in freezing conditions but are skewed by the results from Mill C where excessive value losses occurred in cutting dry logs. The majority of the test mills had significant degrade and trim value losses.

Figure 7 Average estimated value losses due to chipped surface defect

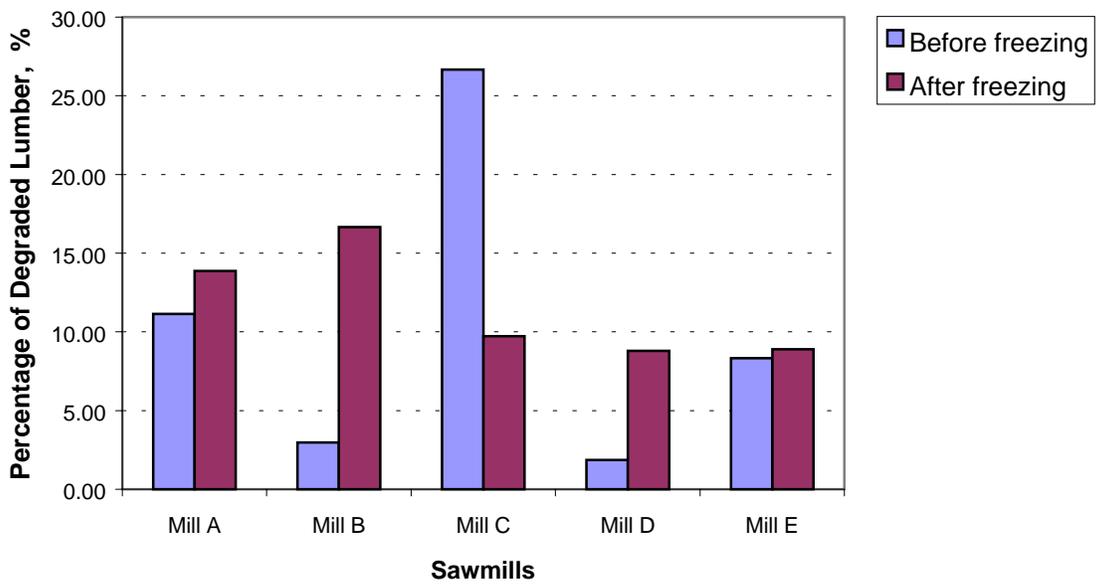
Figure 8 Percentages of degraded lumber due to chipped surface defects

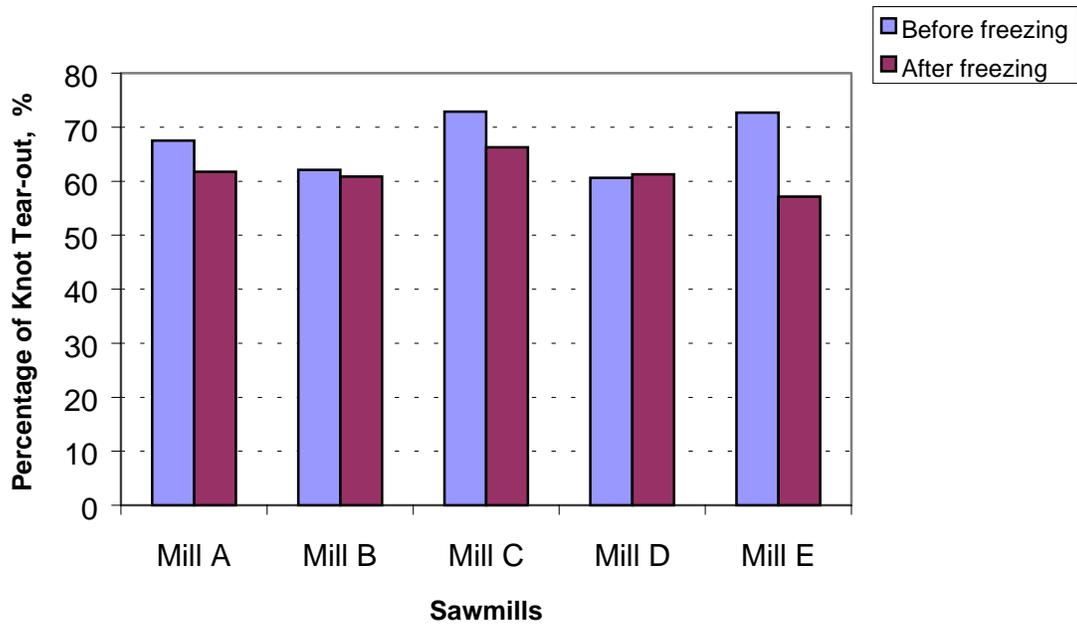
In all the test mills, over 55% of knots had tear-out on the chipped surfaces (Figures 9). The maximum percentage of tear-out was 73% for Mills C and E in non-freezing conditions. Mill C used a different knife type than the other mills. Mill E installed a new knife type on some machines prior to the data collected in freezing conditions. This was possibly the reason that the percentage of knot tear-out for this mill decreased from 73% in non-freezing conditions to 57% in freezing conditions.

The knot tear-out percentages tend to be higher in non-freezing condition. The possible explanations for this are that more care was taken to maintain knives in winter, the knife type was changed for some machines in Mill E and the winter was uncharacteristically mild in February 2001.

Figure 9 Percentage of knots with tear-out

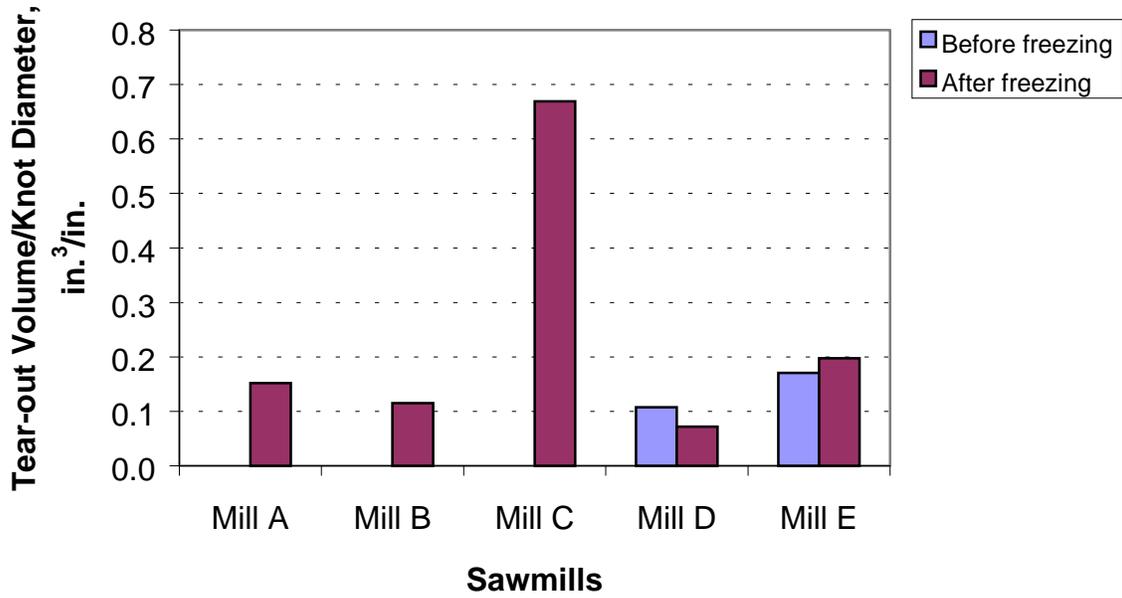
Figure 11 Knot tear-out volume divided by knot diameter

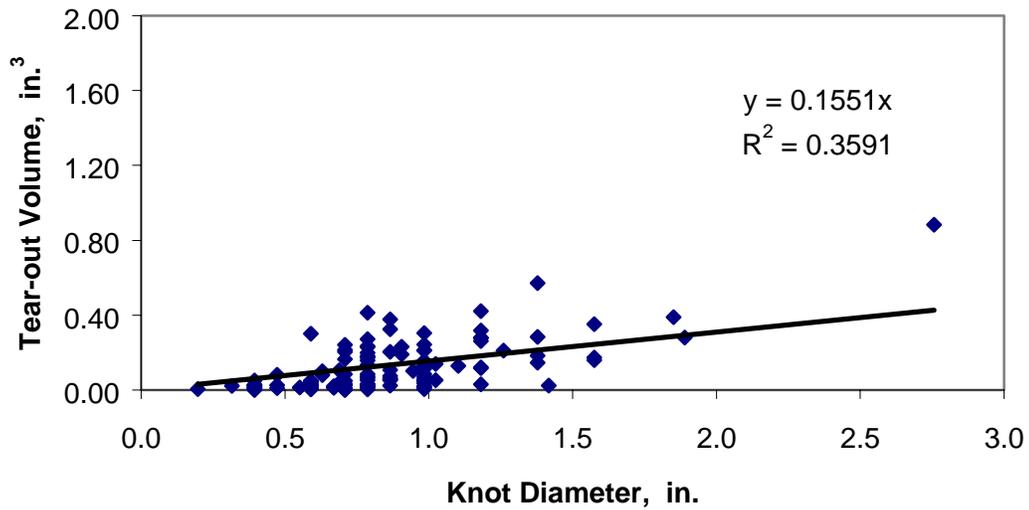
In order to obtain an indication of the severity of knot tear-out, the volume of tear-out and the knot diameters were measured for Mills D and E in non-freezing conditions and all Mills in freezing conditions. Figure 12 shows the relationship between knot tear-out volume and knot diameter for one of the test canters (121 data points). The relationship is not strong ($R^2 = 0.36$) and it is possible that the various knot directions and grain complexities around knots greatly affect tear out volume. In general, the regression line represents the main trend. The larger the knot diameter, the greater the tear-out volume.

Figure 12 Knot tear-out volume vs. knot diameter
