# Harvesting riparian zones using cable skidders equipped with Spectra® synthetic-fiber mainlines

Rod Ewing  
Eastern Division

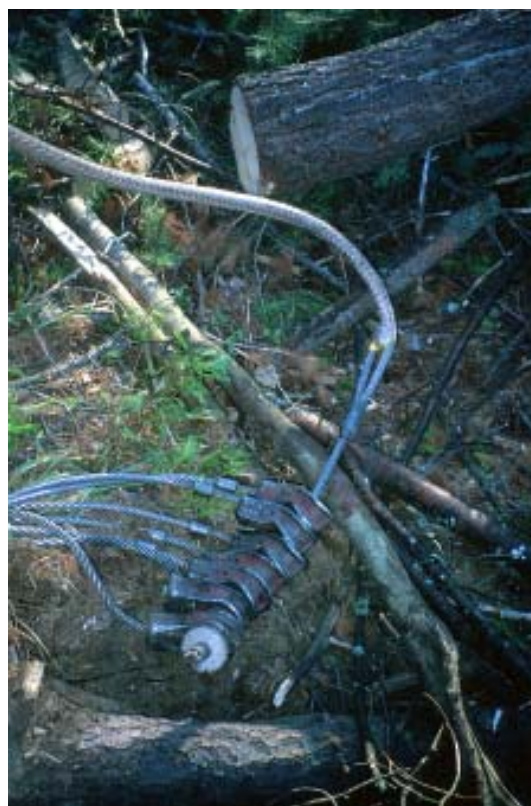
As an alternative to fully mechanized systems, some companies are developing a specialized motor-manual method using cable skidders to treat their riparian zones. In this approach, the skidders remain outside the riparian zone while workers with chainsaws fell and delimb the trees for skidding. Spectra synthetic-fiber ropes can replace conventional wire-rope mainlines on skidders (Golsse 1996), but the abrasion associated with accumulation of the sliders that connect chokers to the mainline during skidding often causes the rope to fail. To address this problem, FERIC developed a means of concentrating the abrasion on a short wire "leader" spliced onto the end of the rope. This streamlined connection lets the sliders move freely between the two sections

(Figure 1). The 18-mm-diameter synthetic-fiber ropes (50 m long) used in the present studies had been coated with polyurethane to improve their abrasion resistance.

Figure 1. The spliced connection between the Spectra rope and the wire leader.

Operators found the rope to be strong, durable, and easy to work with. However, one operator reported that the cable froze into the drum one night after a heavy rain and was difficult to unwind the following morning. The wire-rope leader eventually failed in both operations, and was replaced by knotting the end of the Spectra rope. This is not recommended, as it decreases the effective rope strength by up to 50%. Further development is currently underway to improve the reliability of the con-

nection between the Spectra rope and the wire-rope leader. In addition, field testing of prototype 12-mm Spectra chokers will take place in 2003.

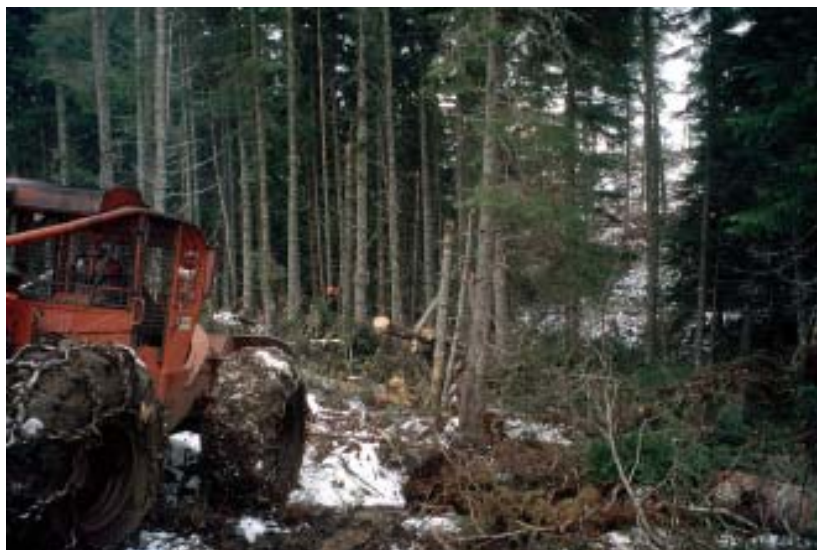
(CPPA classification 2.1.1), the cutover abutted the 20-m riparian zone on gently sloping ground and the skidder worked along the edge of the zone (Figure 2). Skidder travel within the zones was not permitted in either case.

Figure 2. Skidder equipped with Spectra mainline positioned outside the riparian zone
