# Replacing wooden-box culverts with aluminum arch culverts: two case studies

The Forest Engineering Research Institute of Canada (FERIC) monitored and documented the installation of aluminum arch culverts replacing wooden-box culverts at two sites. Detailed installation procedures and costs for the projects are presented in this report, as well as comparisons with alternative replacement structures and implementation suggestions for future installations.

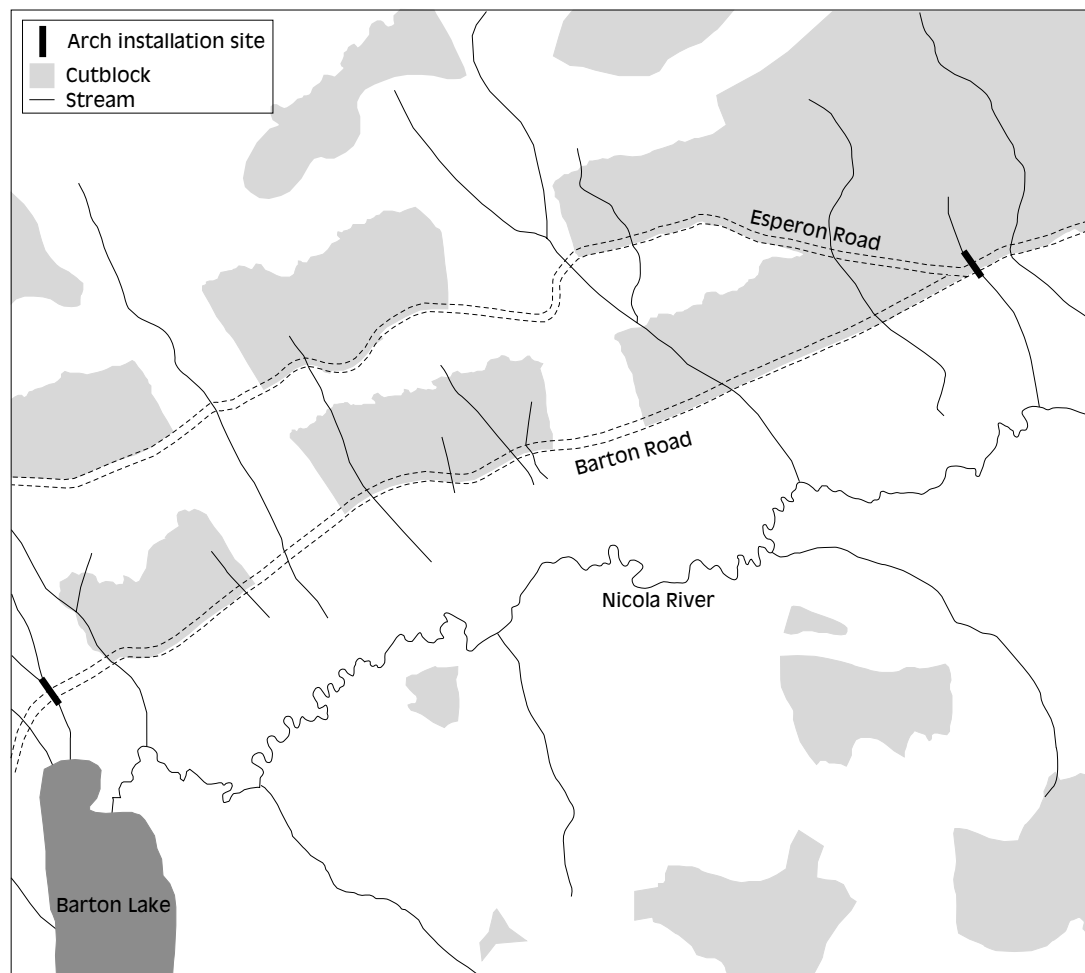
Figure 1. Location of arch culverts on Barton and Esperon Roads.

Barton and Esperon Roads are located within Tolko's Kelowna operating area (Figure 1). The two wooden box culverts were temporary structures and frequently inspected, and were replaced due to their age and condition. The life of wooden structures is somewhat uncertain, and can vary depending on the strength of the timber used and the rate of decay. Tolko believed that by replacing the two structures with permanent aluminum arch culverts, the frequency of inspections could be reduced and the life of the new structures could be more readily predicted.

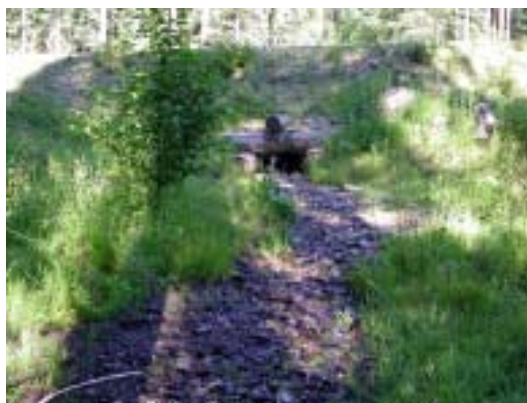
Figure 2. Inlet of Barton Road wooden-box culvert.

the wooden-box culvert measured 78 cm wide and 55 cm high, and the outlet measured 88 cm wide and 43 cm high. The depth of the fill over the wooden-box culvert at the road centreline was approximately 1.8 m (Figure 2).

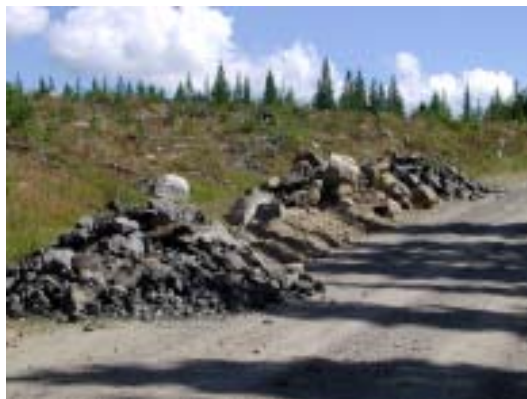
Figure 3. Stockpiled aggregate showing one load of riprap on either end of the crushed rock.

Riprap and crushed aggregate were hauled and stockpiled at the installation sites prior to starting the installations (Figure 3) to avoid delays. First, two loads (24 m<sup>3</sup>) of crushed aggregate were delivered by a clamshell dump truck; round-trip delivery time was 1 hour per load. Next, two loads (18 m<sup>3</sup>) of riprap were delivered by a tandem dump truck

with a heavy duty box; round-trip delivery time was 30 minutes per load. The delivered riprap varied in size; one load contained small (18 to 42 cm) riprap, while the second load contained large (72 to 95 cm) riprap. The tandem dump truck placed one load of riprap at each end of the delivered crushed aggregate.

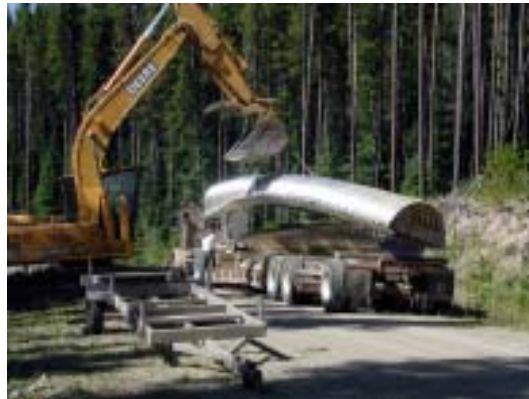
Figure 4. Lifting arch off delivery truck in preparation for placement on small trailer.

A lowbed delivered both arches (pre-assembled) in one trip the day before the installations began. A John Deere 200 LC excavator with clean-up bucket and live thumb unloaded the arches, which were fitted with lifting eyes along the top to aid in lifting and moving (Figure 4). The Barton Road arch was placed along the road right-of-way beside the installation site, while the Esperon Road arch was loaded onto a small trailer for a 3.5-km move with a pick-up truck when needed.

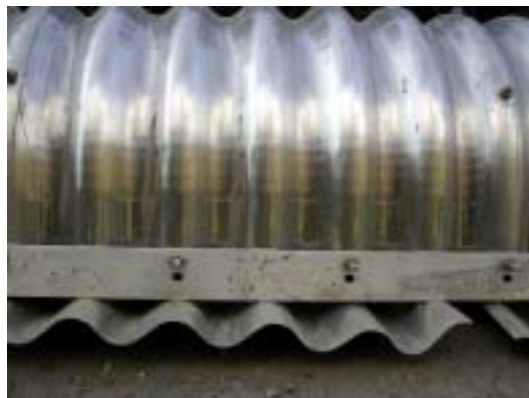
Figure 5. Corrugated aluminum arch and footings showing the corrugation profile and gap between the footing sections.

The two Dur-A-Span™ Forestry Arches had the same span (width) and rise (1220 and 610 mm, respectively, with an end area of 0.58 m<sup>2</sup>), but different lengths and footing dimensions. The Barton Road arch was 13.7 m long with 43-cm-wide footings, and the Esperon Road arch was 11.0 m long with 31-cm-wide footings. The footings were not continuous along the length of either arch; the space between each section of footing was approximately 10 cm. Wider footings were chosen for the Barton Road site owing to the deeper fill. The arches weighed 38 kg/m, and the corrugation profile was 64 mm deep and 230 mm wide (Figure 5). The footings were designed for a surface with 200-kPa bearing capacity. The arches are designed to an L100 rating (approximately 91 tonnes gross vehicle weight), with a minimum compacted cover of 600 mm.

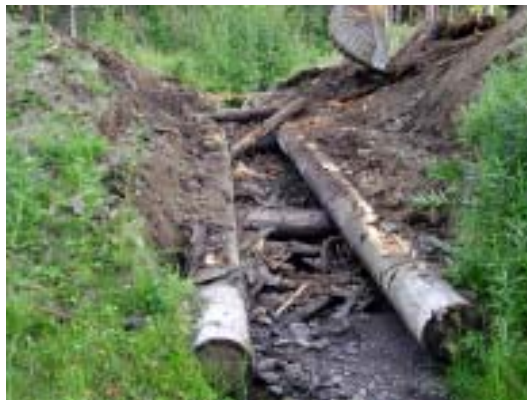
Figure 6.  
Excavator  
removing final  
stringers from  
over the sill logs.

The excavator removed as much of the fill over the log stringers as possible to keep the road fill from entering the stream channel, and then removed the stringers (Figure 6). Finally, the excavator pulled out the sill logs and dug out the mud sills. The culvert logs were then placed randomly in the right-of-way below the road, to serve

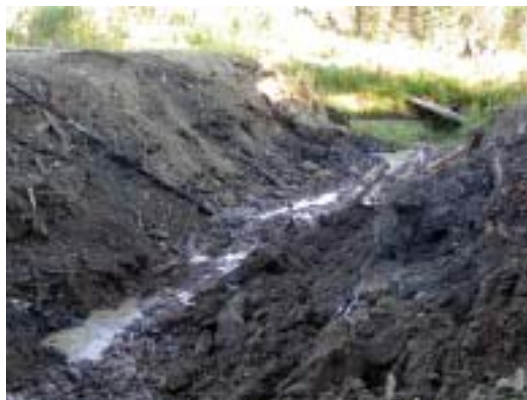
Figure 7.  
Excavated trench  
at Esperon Road  
site.

The excavator prepared each site to a cleared width of approximately 3.2 m at the base of the excavated trench to allow nearly 1 m on either side of the arch for compacted fill. The width of the trench at the road surface was approximately 6 m. The excavations at both sites were about 1.7 m deep. The excavation depth at the Barton Road site was determined by the depth of road fill and existing structure. At the Esperon Road site, the trench was excavated below streambed level to find a better bearing surface than was present at the original level. Soil conditions beneath the original streambed did not appear to improve with deeper excavation (Figure 7) so additional bed preparation was necessary. Excavating and preparing the trenches took about 2 hours at each site.

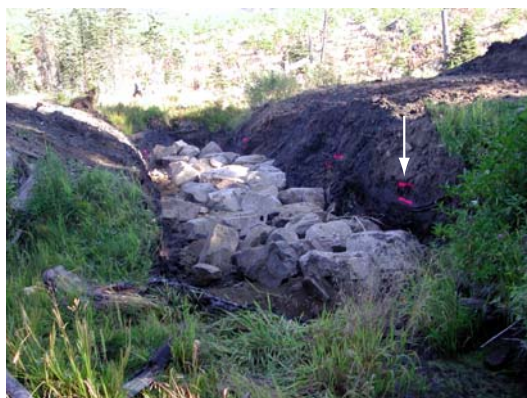
Figure 8. The  
Esperon Road site  
showing first lift of  
large riprap before  
topping with  
crushed  
aggregate. Arrow  
indicates design  
height of fill.

Bed preparation at the Esperon Road site was more complex owing to the poor subsurface conditions. After the trench was excavated below the streambed level, riprap

was placed in the trench (Figure 8) and topped with crushed aggregate to provide an adequate foundation for the arch. A line was painted along the sides of the excavation to mark the height of the aggregate lifts. Finally, some of the excavated soil was spread over the crushed aggregate and compacted with the excavator's bucket (Figure 9).

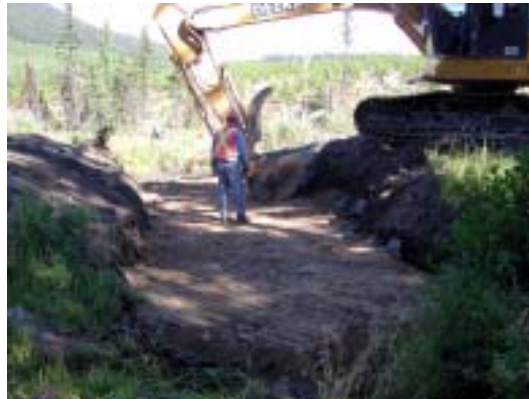
Figure 9.  
Compacting the  
final lift with the  
excavator bucket.

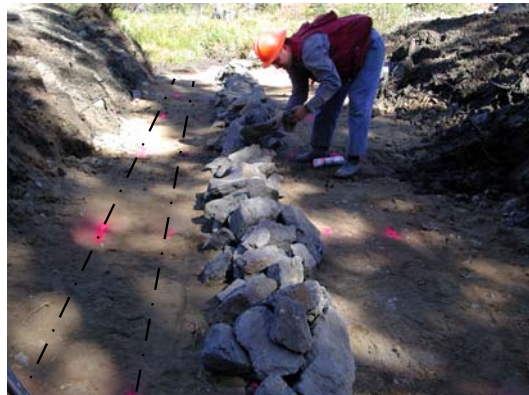
Figure 10.  
Windrowed riprap  
along culvert  
centreline. The  
white dashed lines  
show where paint  
lines would  
indicate the  
location for one  
side of the arch's  
footings.

inlet and outlet positions. In preparation for armouring the footings, small riprap (18 to 27 cm) was hand-picked from the stockpile, placed in the excavator's bucket, and windrowed along the centreline (Figure 10).

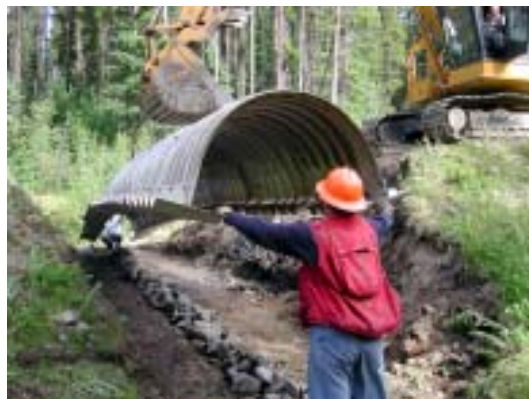
Figure 11.  
Excavator and  
workers orienting  
arch for final  
placement.

the stream. The excavator lifted the arch by the two stock lifting eyes and positioned it so that it straddled the windrowed armouring material (Figure 11). The workers were able to move the arch into proper position while it was suspended. The final placement was made easier by marking the site for the footings.

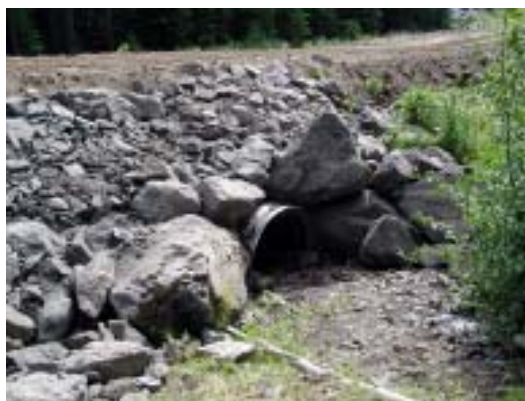
Figure 12. Inlet of arch showing placement of large and small riprap on fill slopes around the arch.

The excavator placed riprap on the fill slopes at the inlet and outlet areas of the arch. Larger riprap was placed near the base of the fill slope and next to the arch, while smaller riprap was placed near the top of the fill slope (Figure 12). The purpose of the armouring was to direct high flows into the arch while providing scour protection to the inlet and outlet areas, and also to prevent road material from sloughing into the stream.

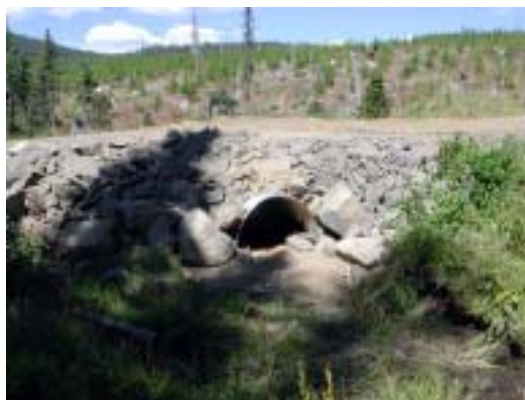
Figure 13. Outlet of arch at Esperon Road site showing fill height above arch and the low areas on either side of the arch along the road.

The original road grade at the Esperon site was flat at the stream crossing, so the road was raised slightly at the arch to direct road runoff away from the stream (Figure 13). The depth of fill over the arch at this site was 84 cm at the road centreline, or 19 cm deeper than over the original wooden-box culvert.
