# INFO NOTE

March 2016 / Info Note No. 9

## DISPOSAL OF LOGGING DEBRIS (BARK) ALONG SPUR ROADS

Clayton Gillies, RPF, RPBio, Senior Researcher

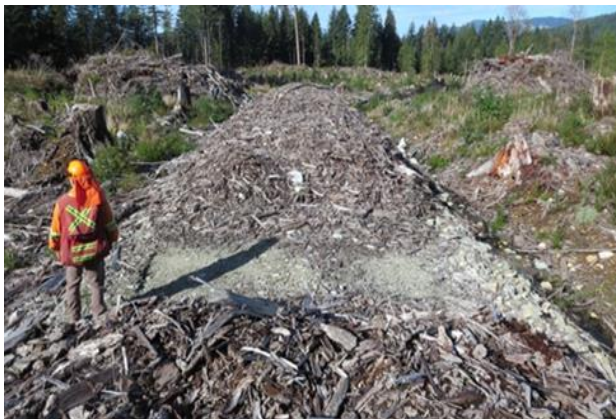
**Figure 1. Disposal pile at the end of spur 2. Note the break between adjacent piles.**

The bark was transported and dumped along two spur roads with a 9.2-m<sup>3</sup> (12-yard) end-dump rock truck. An excavator loaded the rock truck; the hauling distance from the log storage area near the barge ramp to the end of spur 1 was 410 m, and to the end of spur 2 was 910 m. An excavator spread the dumped piles flat. Each pile had breaks between them, which restricted the size of the piles and provided a non-continuous lineal feature. There were five disposal piles built along spur 1, with the pile at the end of the spur being placed over a blasted rock pit. Spur 2 had four disposal piles.

Piles were built over existing spur roads that were not rehabilitated or planted. The average width and depth of the piles varied by spur road (see Table 1). The pile at the front of spur 2 was likely the last pile built and was only 30 cm

thick. The length of the piles ranged from 13 m to 25 m. The disposal location at the rock pit was not constrained by the width of a road and was built 11 m wide by 11 m long; this area was the only debris pile planted with tree seedlings (Douglas-fir and western red cedar). There was more debris placed along spur 1 than spur 2 in part due to the shorter hauling distance, the construction of wider piles, and the wider dimensions of the rock pit. A total of 835 m<sup>3</sup> (90 loads) was disposed of along the two spur roads. The cost of disposal of the debris along the spur roads was estimated to be \$6 000.

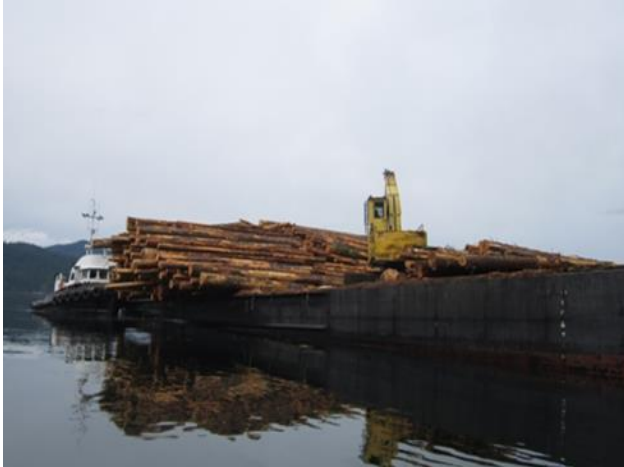
**Figure 2. View of the barge being loaded by a log loader. Note the logs with much of their bark missing after being handled multiple times. Photo courtesy of BCTS.**

The scaled volume of wood for the 132-ha harvest area was approximately 88 050 m<sup>3</sup>, of which 41 150 m<sup>3</sup> was Douglas-fir. Trees were felled using a feller buncher and hoe-chucked (excavator forwarding) to the roadside. Full trees were processed at the roadside and loaded with a self-loading logging truck. Stems were delivered “hot” to both a floating barge and a log storage area near the barge. A front-end loader delivered logs to the barge, and final placement and building of the barge load (2 000 m<sup>3</sup>) was done with a log loader. Each handling phase produced more detached bark (Figure 2).

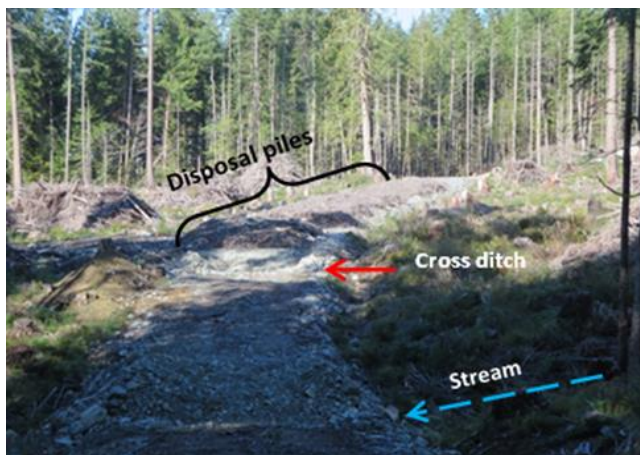
**Figure 3.** View of stream location at spur 1 and a cross-drain constructed adjacent to a debris pile. A buffer of approximately 45 m was maintained between the disposal pile and the stream.

An S6 stream crossed spur 1. The debris pile was kept away from the stream (approximately 45 m away at a 10% slope), and cross-ditches were constructed through the road to prevent any ditch or surface flows from the pile reaching the stream along the road (Figure 3). No streams crossed spur 2. Careful attention was given to preventing bark from entering the ocean at the dock during barge loading and deck clearing. The bark that remained on the barge deck during the return haul was removed and stockpiled at the log storage area. The management of debris and the protection of the ocean floor during marine operations (e.g., log dumps and helicopter drops) have been discussed by Gillies (2012, 2014).

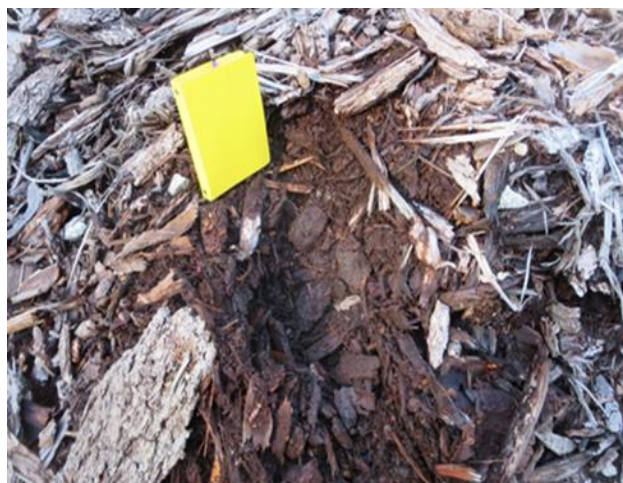
**Figure 4.** Typical size of bark within a disposal pile (field notebook was included for scale). The darker area near the notebook was below the surface and was retaining moisture to a greater degree than was the surface layer.

Waste bark from a BCTS harvest area was disposed of along two spur roads on Maurelle Island. The spur roads were considered permanent access structures that can account for a maximum of 7% of the harvest area. The bark (and associated minor woody debris) may provide a favourable medium for plant or fungi growth either immediately or over time as the bark breaks down and decomposes. Forrester (2002, 1998a, 1998b) described the use of composted woody sortyard debris placed along spur roads to improve site productivity and promote plant growth. In these cases, the composted material was mixed into the road either during the ripping of the road surface or when sidecasted material was retrieved during road reclamation. Compared to a compacted road surface, the bark piles may provide a greater opportunity for plant growth and habitat. Douglas-fir bark has a neutral pH, a minimal percentage of wood attached to it (resulting in a low nitrogen draw), and provides organic matter to the soil as it decomposes. No plant growth was observed within the piles except at the rock pit pile, which was planted with tree seedlings. It was noted that the piles were holding moisture

below the surface layer (**Figure 4**). Preserving moisture at depth may help seedling establishment and survival during the summer.

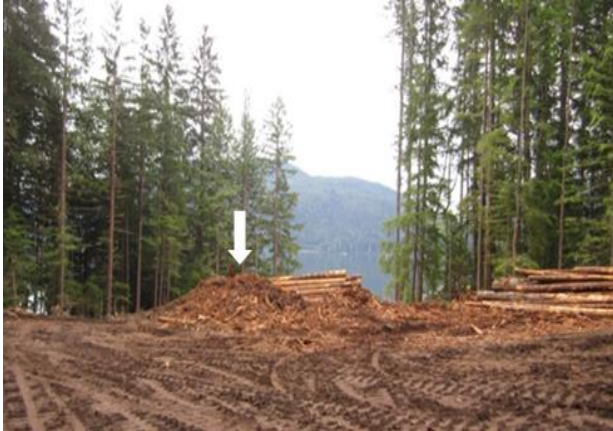
**Figure 5. View of stockpiled bark and woody debris (see arrow) near the barge loading and log storage areas. Photo courtesy of BCTS.**

Rainwater passing amongst or over the bark has the potential to transport leachates (where dissolvable leachates are present). Leachates can be a concern when found in aquatic environments. The S6 stream and water quality were protected by providing an approximate 45 m buffer between the stream and the disposal piles. As well, cross-drains were constructed to prevent surface and ditch flows from reaching the stream directly along the sloping road surface. There was no concern with potential leachate having direct connectivity to the S6 stream. The ocean and marine environment at the barge loading area was also protected from bark disposal; bark was carefully removed from the barge deck and stockpiled in preparation for disposal along the spur roads (**Figure 5**).
