INSTALLATION OF A LOG BUNDLE FOR WATER MANAGEMENT DURING WINTER ROAD DEACTIVATION

Clayton Gillies, RPF, RPBio.
Dave Belyea, RPF

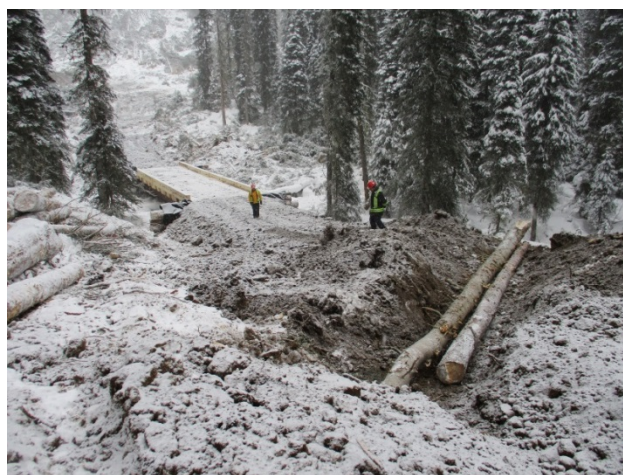
Figure 1. First two logs of a bundle positioned at a skew in the excavation through the road.

During January 2018, FPIinnovations identified a site for a trial installation of a log bundle in a winter road (Figure 1). The intent was to construct the log bundle in a way that allowed for its removal during road deactivation. The removed bundle results in a wide, deep void, which promotes the development

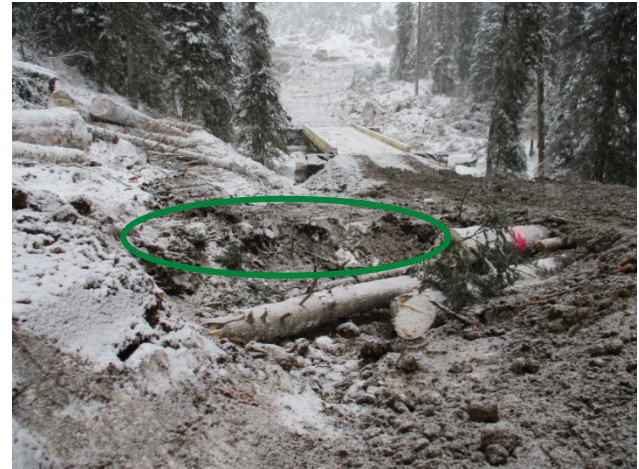
Figure 2. View of inlet of the completed log bundle showing the various log lengths and the position and composition of the ditch block (solid oval).

The log bundle was constructed using 11 logs; each log was approximately 14 m long and was without limbs. The construction took 25 minutes, which included excavating for log placement, placing the logs, backfilling, and building a ditch block at the inlet of the bundle. During backfilling, it was important not to cover the length of logs at the inlet or outlet of the bundle. The inlet logs protruded 2–4 m; the outlet logs protruded 2–6 m. The ditch block was made from competent soil (without snow or ice) and was constructed at the log bundle inlet to direct ditch flow into the log bundle (and eventual cross-ditch) (Figure 2).

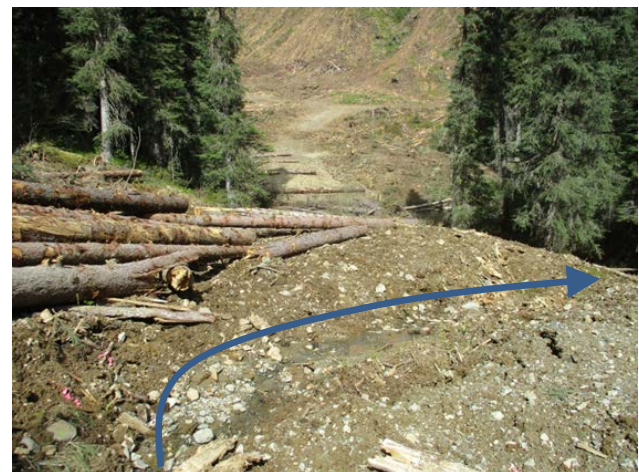
Figure 3. Cross-ditch with water through the flow path and logs left on-site. The arrow indicates the flow path of ditch water entering the cross-ditch.

The log bundle was removed with a 25-ton excavator during deactivation of the winter road. The logs were removed easily, and the cross-ditch was completed within 15 min. The cross-ditch was 1.5 m deep and 2.5 m wide at an approximate skew of 30–45° from the road centerline (Figure 3). The excavator dug into the ditch block slightly while locating and grasping the logs at the inlet. All logs were removed and left on-site. The deactivation at this site included removing the bridge and providing erosion control of the exposed soils.

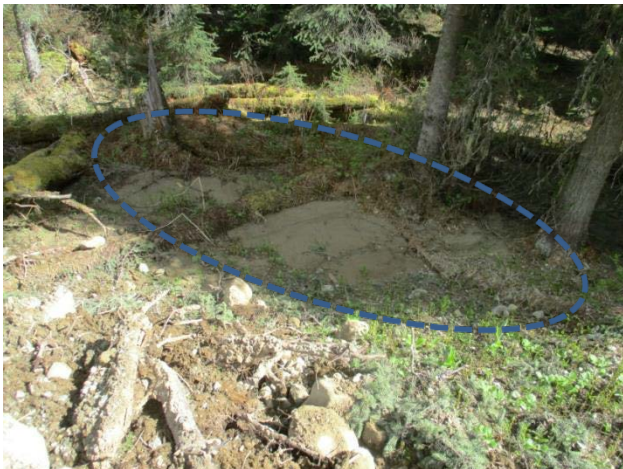
Figure 4. View of the sediment deposition area (dashed oval) immediately downhill from the cross-ditch outlet.

The cross-ditch constructed during the log bundle removal was much larger (wider and deeper) than non-log bundle cross-ditches along the road. The log bundle cross-ditch was functioning well by directing sediment-laden water from the ditch and road toward the forest floor. The deposition area for the sediment was obvious, and the volume of sediment deposited was estimated to be 1–1.5 m³ (Figure 4). The amount of deposited sediment was significant, which otherwise would likely have reached the stream channel.

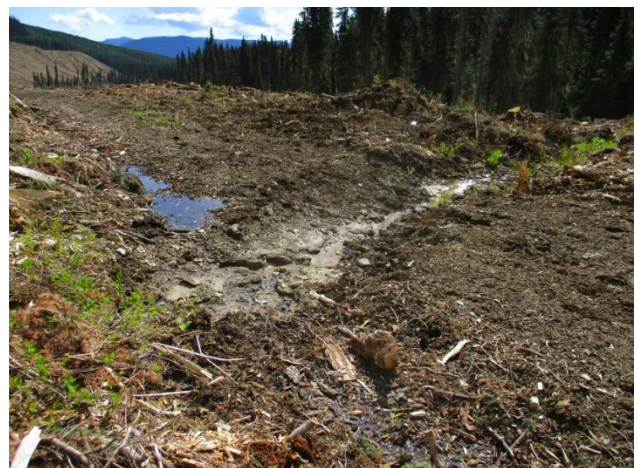
Figure 5. Typical cross-ditch constructed by excavating through frozen soils. Note the sedimentation within the cross-ditch, and the ponded water.

are appropriate where there is a low risk of sedimentation reaching a watercourse. Some of the smaller cross-ditches were performing well (directing road and ditch water toward the forest floor); others showed signs of sedimentation within them (Figure 5). The skew and depths of a cross-ditch need to be sufficient to keep sediment from depositing within the cross-ditch (self-flushing/self-cleaning).

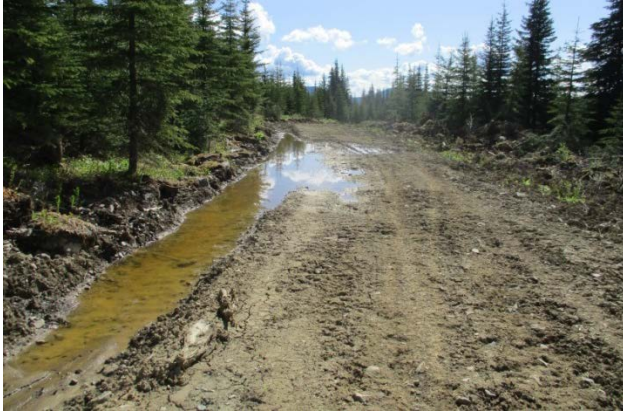
Figure 6. Winter road during spring, showing ponded water along the ditch and road surface. This is a good location to plan for the construction of a cross-ditch.

Cross-ditches need to be carefully planned and constructed in strategic locations to prevent water from ponding along the road surface. Low areas of a road should be identified as a high likelihood to accumulate water and will require adequate drainage (Figure 6). Standing water will weaken a winter road resulting in the need for remediation before reuse.

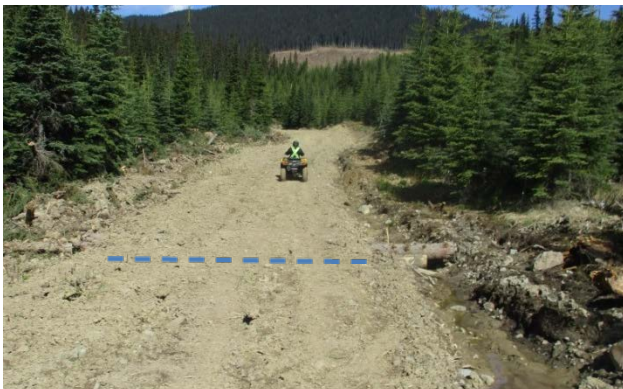
Figure 7. Dashed line indicates location of a log bundle that was left in place during deactivation. The bundle is not passing ditch water that is accumulating uphill of the inlet, and there are signs of sedimentation in the ditch.

During winter road deactivation, it is important to locate and remove all the log bundles that were designed for removal. The log bundles designed for removal are shallow in the road, and are not constructed with a separation layer to prevent infilling from road material. Over time, a log bundle constructed in this manner can become infilled with sediment and will not function to pass any water (Figure 7).
