# Evaluation of Synthetic Ropes for Log Load Securement

Technical Report no. 9 – February 2017

#### 301010107: Improve drivers' working conditions Technical Report no. 9

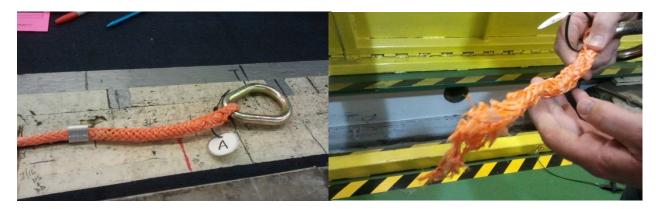
Sample A was a new, unused rope that failed at 7 045 kg. Sample B appeared to be the same type of rope except that it was lightly used, and it failed at 8 500 kg. This difference can be explained by the splices used to attach the pear-shaped ring onto Sample A. The manufacturers of these ropes have detailed procedures for making splices which include tapering the buried end of the rope by removing strands to make it a more gradual transition. The buried end of Sample A was not tapered and that is where the failure occurred, as shown in Figure 1.

Figure 1. Sample A before (left) and after (right) break test.

If the splice had been done in accordance with the manufacturers' recommended procedures, it is expected that the break strength would be comparable to that of sample B. Both of these samples had a WLL of 1 636 kg.

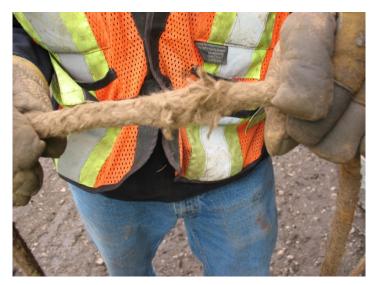
Figure 3 shows a rope that has some severed strands and was therefore considered unsuitable for service.

Figure 3. Rope with severed strands that is no longer suitable for service.

Following manufacturers' inspection guidelines for synthetic rope will identify weakened ropes that should be removed from service.

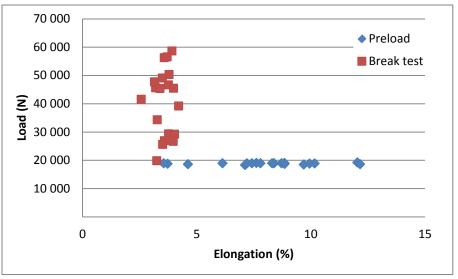
The percentage of elongation for each sample was calculated during the rope pre-load tensioning cycles and during the break tests. The results are shown in Figure 4.

Figure 4. Percentage elongation for pre-load and break tests.

During the pre-load tensioning, a force of about 2 000 kg was applied to the ropes. This resulted in elongation of the ropes by about 4 to 12%. For the break tests, the percentage elongation was fairly consistent at about 4%. This is consistent with the manufacturers' specifications which state that the percentage elongation at break is 4 to 5%. The percentage elongation for used ropes is not provided by the manufacturers.

The amount of stretch for both cycles was compared. On average, the rope stretched 4.9 times more for a given load during the pre-load cycles compared to the break tests. This explains why the co-operators who were using cinches were having a difficult time getting the wrappers tight. The cinch was unable to take up the slack because of the excessive stretch. This is not an issue with winches because they have the ability to take up the excess slack needed to get the ropes to their required tension.
