# **BRIDGES & WILDFIRE EVENTS**

## **IDENTIFYING INFORMATION GAPS IN BRIDGE PROTECTION IN THE CONTEXT OF RESISTANCE TO WILDLAND FIRE EVENTS**

March 2020

301013731: Equipment Evaluation  
TECHNICAL REPORT NO. 14 (2020)

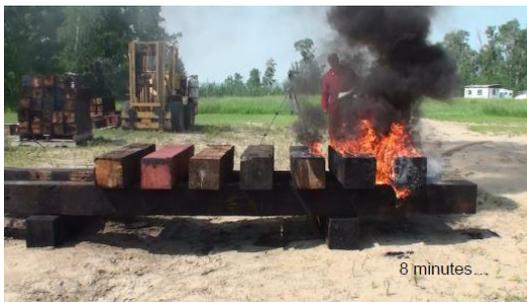
**Figures 1.**  
Point source ignition cross beam tests showing “exponential rate of spread”  
(Bridge Timber Protection, Thomasson 2013).

This study investigated the effectiveness of fire protective coatings on creosote timbers. The test looked at the ignition and rate of spread on simulated bridge structures. Both treated and untreated cross beams were used in the study, with ignition occurring from a point source. It was found that the treated timber did not prevent ignition and spread.
