# Analysis of Yukon highways pavement damage caused by permitted overload trucks

**PROJECT NUMBER : 301013564**

**TECHNICAL REPORT - 5**

November 2019

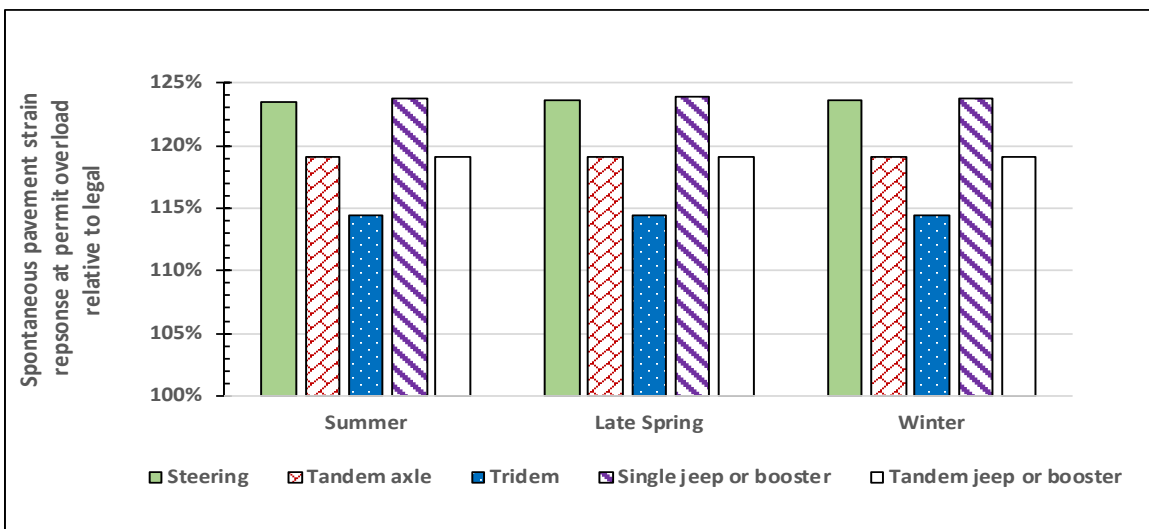
Figure 5 illustrates the relative increase in predicted subgrade strains for the same highway at maximum permit loads.

As illustrated in Figure 5, a direct correlation was observed between the percentage increase in permit overload and the predicted increase in spontaneous strain. That is, single axles permitted 25% higher loads generated 24% higher strains; tandem axles permitted 20% higher loads generated 19% higher strains; and, tridem axles permitted 15% higher loads generated 14% higher strains.

Figure 5. Effect of permit overloading, axle type, and season on subgrade strain in BST pavement sections of the Alaska Highway.

As illustrated in Figure 5, single axles (steering or single jeep or single booster axles) at legal loads had the highest pavement impacts, and these were 12%-14% higher, depending on season, than strains from legally loaded tandem axles. When overloaded by 25% (under permit) the strains of these already highly impactful axles were increased to 27%-31% higher than the strains from legally loaded tandem axles, depending on seasonal conditions. This effect held for other axle types but to a lesser degree because of their reduced overload tolerances and their reduced strain levels relative to legally loaded tandem axle strains.

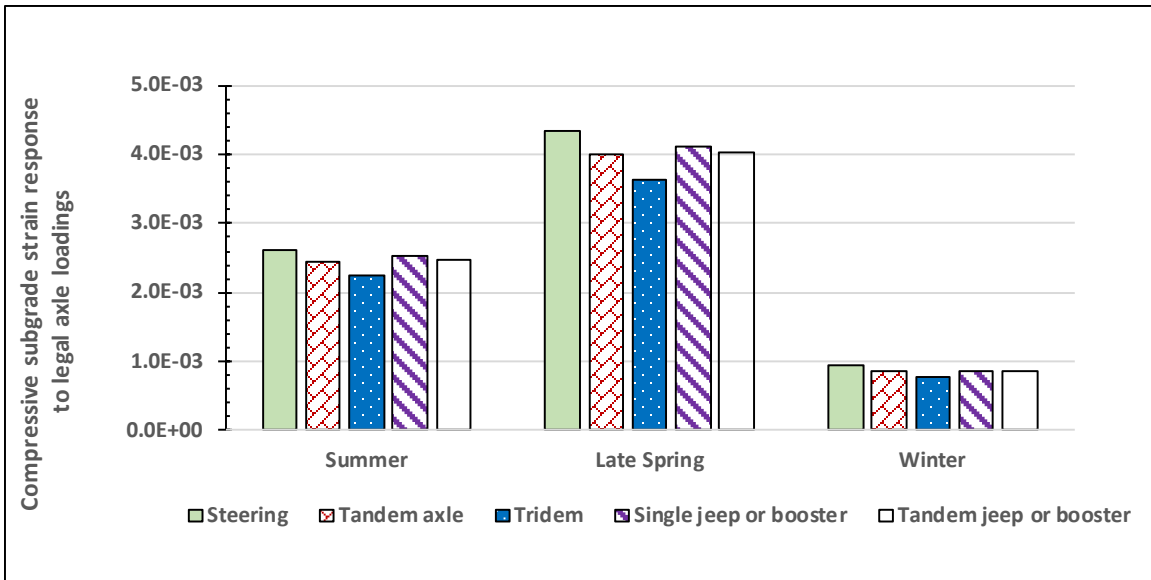
Figure 8 illustrates the predicted spontaneous subgrade strains in the gravel-surfaced highway structure due to 5 legally loaded axle configurations. Figure 9 illustrates the relative increase in predicted spontaneous subgrade strains for the same highway at maximum permit loads.

Figure 8. Subgrade strain in gravel-surfaced sections of the Campbell Highway at legal highway loadings, by axle type and season.

The Campbell Highway gravel-surfaced structure is slightly weaker than the Klondike Highway North BST structure. As a result, summertime strains due to legal axle loadings were about 18%-20% higher, depending on axle type, than in the Klondike Highway BST structure. In late spring conditions, the Campbell Highway gravel highway had 26%-31% higher strains than the Klondike BST structure. In early winter conditions, the Campbell Highway gravel highway had 38%- 47% higher strains than the Klondike BST structure.

The differences in spontaneous strain resulting from axle type were less pronounced in the Campbell Highway gravel structure than were observed in the Klondike Highway North BST structure; however, the pattern of relative strain differences was similar. Legally loaded (6-t) steering axles generated the highest spontaneous strains; these steering axle strains were 12%-14% higher than strains from legally loaded (19.1-tonne) tandem axles. Legally loaded (10-t) single jeeps or booster axles generated 3%-4% higher strains than legally loaded tandem axles. Legally loaded (24-t) tridem axles generated 11% lower strains than legally loaded tandem axles. The small range in strain increases (1% to 2%) that are noted for the various axle types are the result of seasonal variation of material properties.

Strains in the spring were the highest during the year and strains in the winter were the lowest. For corresponding axles, instantaneous strains in late spring conditions were estimated to be about 52%-56% higher than summer-fall levels, depending on axle type. In contrast, those same axles generated only 20% of summer-fall levels in the early winter conditions.

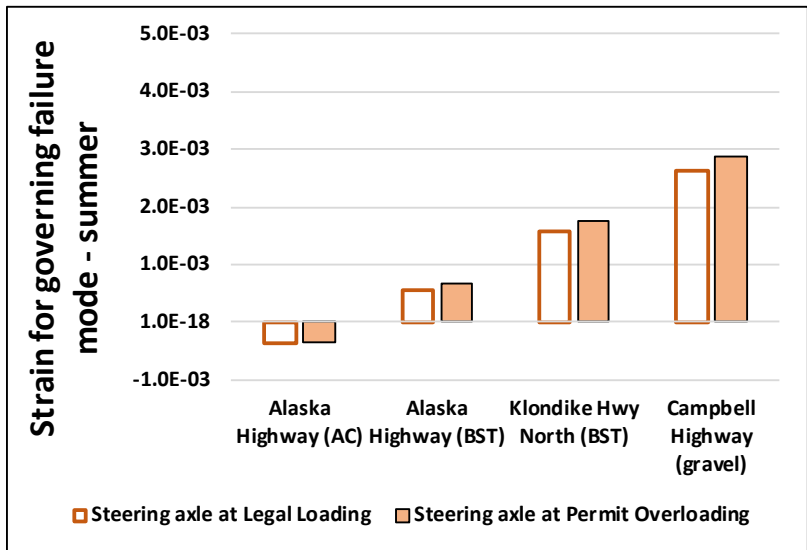
Figure 12. Strains governing failure in 4 highway structures due to steering axle loads under summer conditions.

Under summer conditions, the highest strains were found in the weakest pavements (i.e., the Klondike North BST and Campbell gravel-surfaced highway). Unlike the rutting failures of the BST and gravel structures, the governing failure mode for the Alaska Highway asphaltic concrete sections was bottom-up fatigue cracking. The predicted fatigue cracking strains were tensile (-ve in the chart) and much smaller in value than the other pavements despite them being from much closer to the pavement surface.

Steering axles had the smallest axle mass (6000 to 7500 kg) but their single tires tended to concentrate the axle load - resulting in the largest rutting and cracking strains. Conversely, tridem axles, which had the highest axle mass (24000 to 27600 kg), have 12 dispersed loads and this resulted in the smallest cracking and rutting strains. Tire contact pressure was comparable for all tires despite the widebase steering tires being larger than the conventional-sized tires used in drive and trailer dual tire assemblies; tire contact pressure increased by 4%-6% with the increase in loading from legal to permit overload.

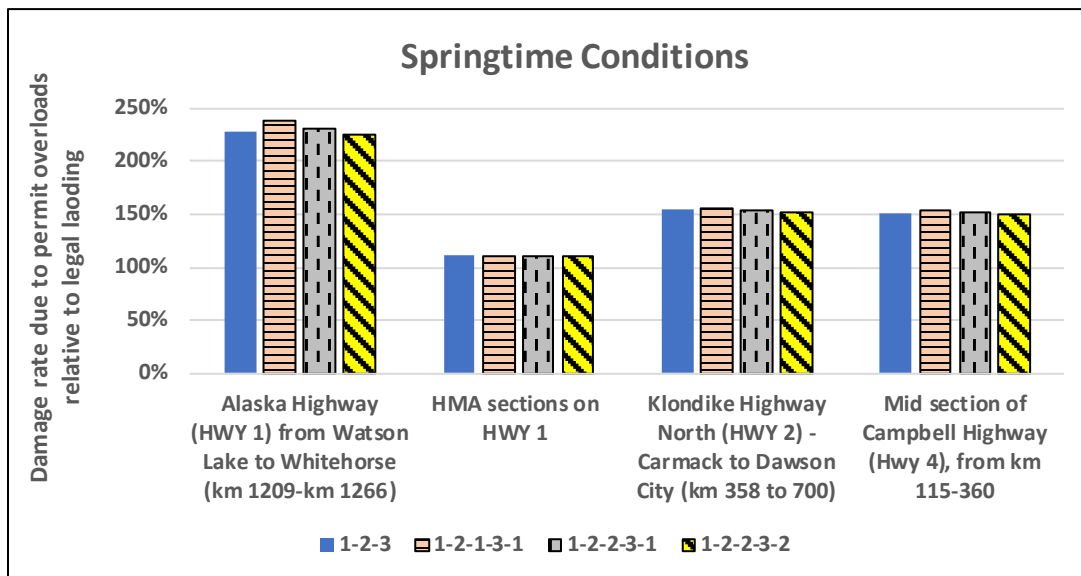
The rates of deterioration of the Alaska BST pavement by permit overloads was the highest of any of the highway structures analyzed under late spring conditions (Figure 14). The rate of damage of the Alaska BST pavement from permit overloads was 228% to 237% of the damage rates at legal loadings. This type of BST pavement offers an opportunity to capture large gains in serviceability with a modest change in permitted loading. Additional sensitivity analyses of the impact of reduced axle tolerances for permit overloading under summer conditions was investigated and the results could equally well be applied to the short period of late spring.

Figure 14. Rate of damage due to permit overloads, relative to at legal loading, for four Yukon highway structures under late spring conditions.

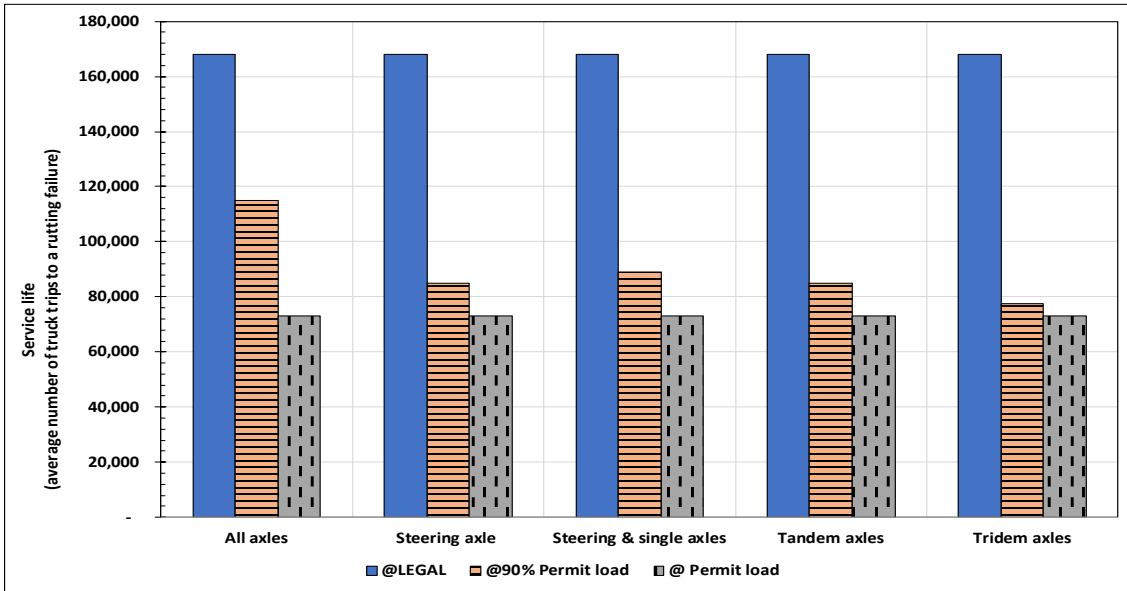
service life by over 9,000 permitted overload trips, on average. A reduction in the tolerance for only single axles with dual tires and single steering axles would have the greatest impact on pavement rutting and is estimated to extend service life by 3,425 permitted overload trips, on average. As with the summer, this change would capture about 38% of the improvement estimated from if all permit axle loads were reduced by 10%. A reduction in the tolerance for only single steering axles would mitigate less of the pavement rutting and is estimated to increase pavement serviceability by over 2,500 permitted overload trips, on average.

Figure 16. Relative sensitivity to permitted axle overloading of Alaska Highway BST in summer conditions.
