Exploring the feasibility and value of RPAS in the wildfire domain

PROJECT NUMBER: 301014839

December 2021

Technical Report TR2021 No. 112

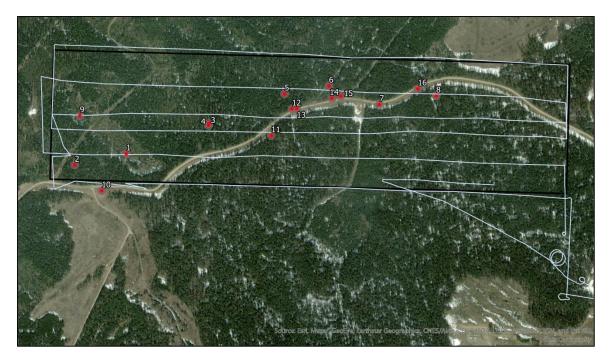
Figure 2: Potential hotspot locations and flight path bread crumb trail provided in KML format by the vendor.

The deliverables produced by the vendor are shown in Figures 1 and 2. Potential hotspots identified by the vendor can be seen below in Figure 1. The flight breadcrumb trail can be seen in Figure 2 along with the potential hotspot locations accompanied by their 5-, 10-, and 15-m buffers.

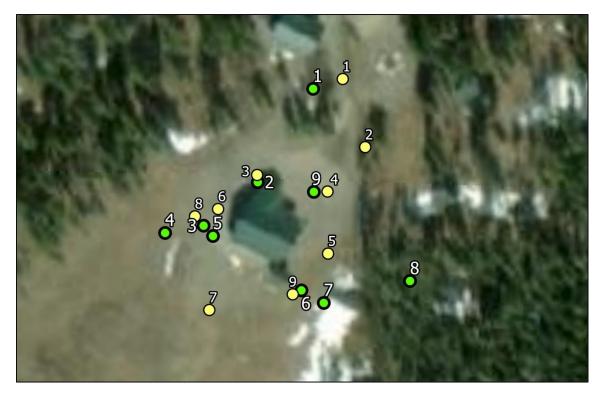
Figure 4: Yellow dots represent those that were visually displayed on the deliverable map. Green dots represent the coordinates from the map deliverables legend.

When the coordinates from the map deliverables legend were entered into a GIS program, they did not line up with the coordinates of detected hotspots that were displayed on the deliverable map. It is unclear why these coordinates do not match and, as seen in Figure 4, calculating ROS using these coordinates would not be possible. The coordinates listed in the map legend and those from the points visible on the map are shown in Table 3.

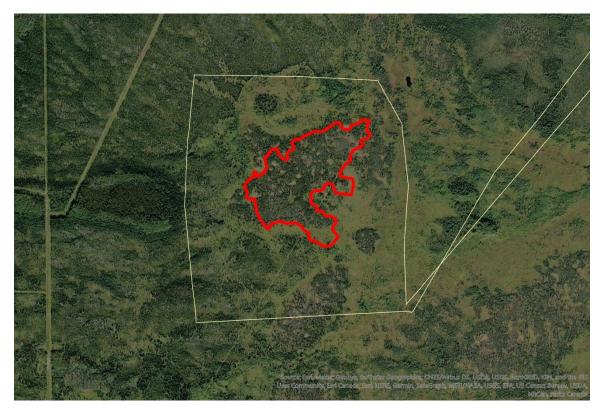
Figure 6: Flight path (yellow line) and identified perimeter for MWF061 from mission on July 20, 2021. No hotspots were found on this flight.

The first mission on July 20 was a flight around the perimeter of MWF061 (Figure 6), as it was the only other wildfire in the complex that was sufficiently close to road access given the RPA's current range. No hotspots were found during the mission flown around the periphery of the wildfire area and the RPA returned to the staging area. The furthest the RPA flew from the launch location on any of the flights was 8 km on MWF061 and 7.6 km on MWF067.

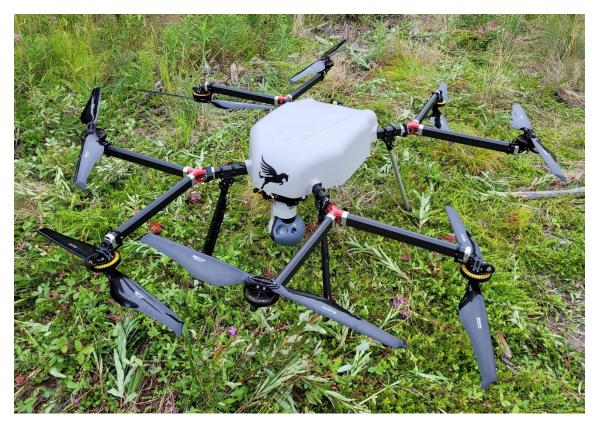
Figure 7: Perimeter 8 hybrid RPA with HD45-LV payload.

The following accuracy assessment will only include errors based on the INS of the Trillium Orion HD45LV (Figure 7) and does not include further errors based on GPS, DEM, or other sources. Scenario parameters and their associated horizontal ground error are based on the typical 1.5° total system accuracy and it is unclear if this is a \pm accuracy value or an absolute value. For the following tests, it is considered an absolute value; therefore, 1.5° = ± 0.75 °. The scenarios assume that the accuracy range remains constant throughout the gimbals/systems range.
