Technical Report No. TR-54

October 1982

Evaluation of the Donaren 180D Powered Disc Trencher

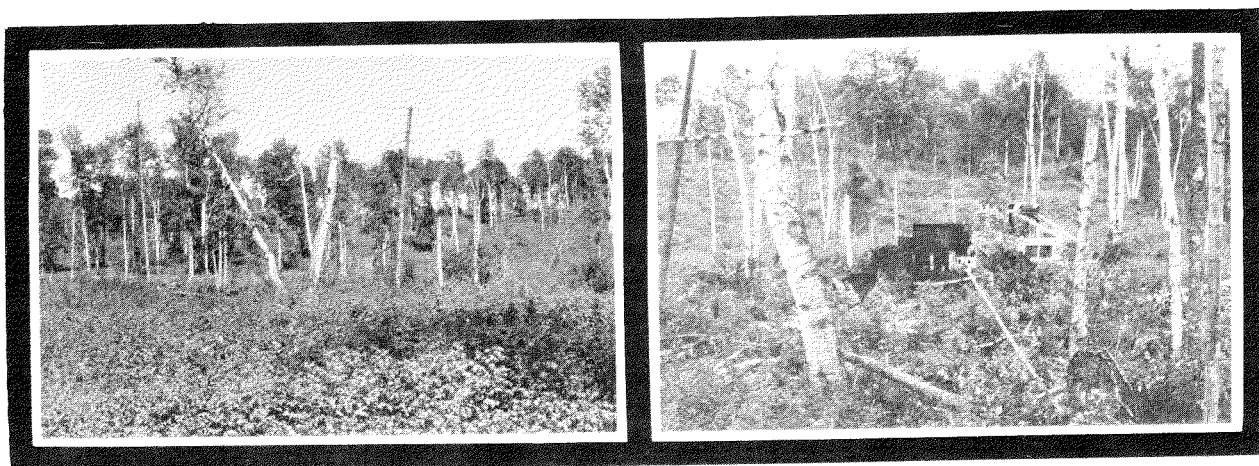
Figure 6. Left: View of Block 1 prior to scarification. Note dense raspberry cover.
Right: Donaren 180D working on Block 1 among white birch residuals.

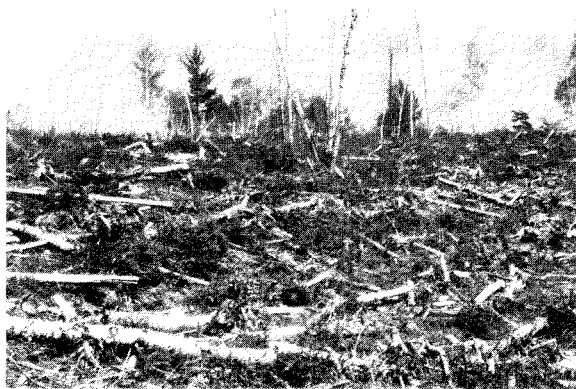
Figure 7. Block 2 after scarification looking across the furrows. Photo taken the following spring before leaf flushing of the raspberry.

The slash was moderate in loading and coverage (Fig. 7). Large white pine tops lay sparsely scattered over the area. Herbaceous and ground cover vegetation was light due to an extremely dense cover of one-metre high raspberry.

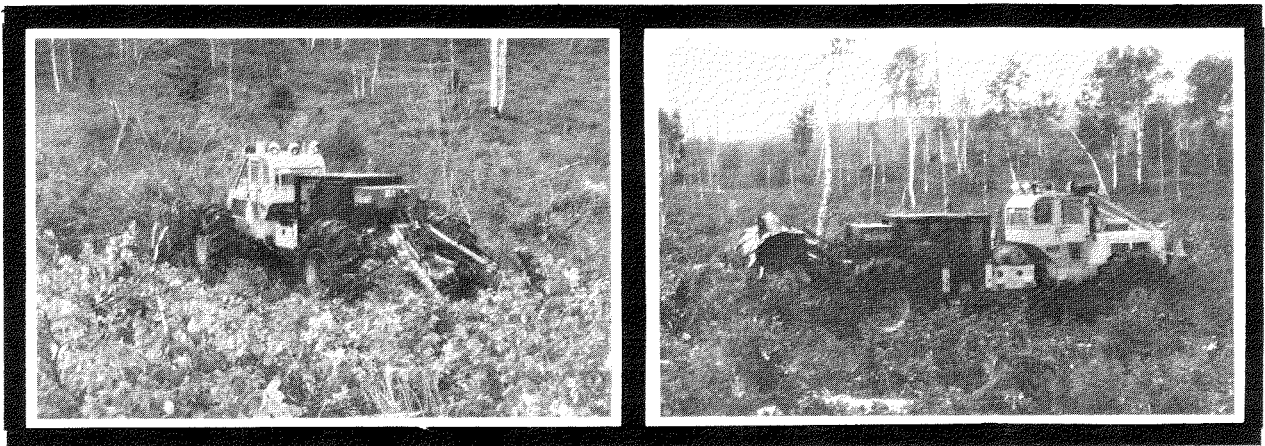
Figure 9. Operating positions of discs.
Left: Donaren scarifying with discs lowered.
Right: Manoeuvring in site between passes with discs raised.
