## **EVALUATION OF THE BRÄCKE BADGER PATCH SCARIFIER**

**M. Ryans, R.P.F.**

**May 1986**

**TR-65**

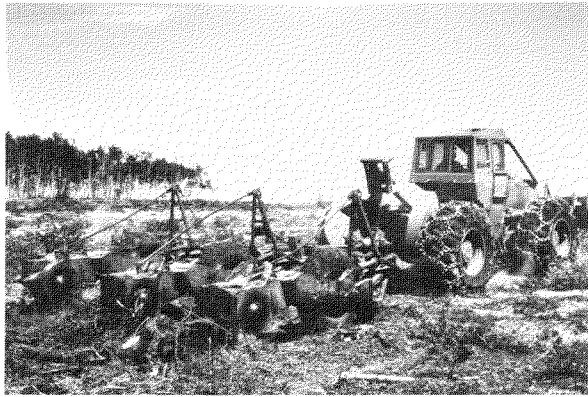
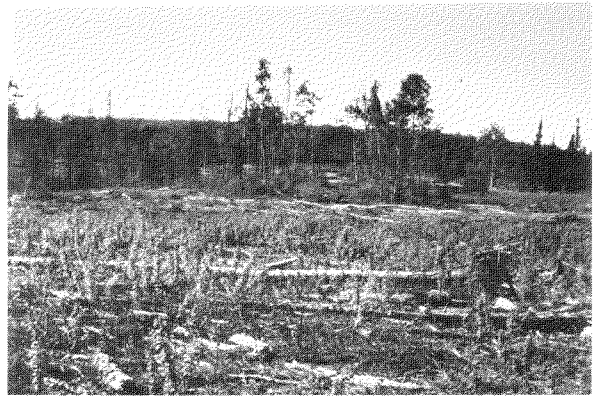
Figure 4. The Bräcke Badger working in Area 1 (left) and view of Area 2 prior to scarification. Note lack of debris on both sites.

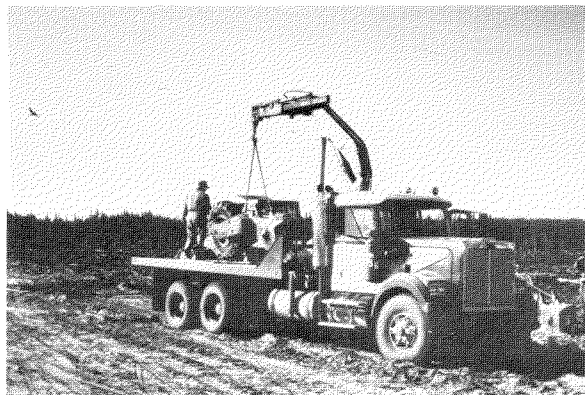
Figure 5. A machine frame is lifted onto a straight truck for transport to town for repairs.

"Walking" between sites was done by simply raising the mattock wheels off the ground with the winch and driving the unit to the next area. Either a tractor and float or a self-loading straight truck (10-wheeler with Hiab crane) was used to transport the Bräcke over long distances between divisions or to major repair facilities (Figure 5).

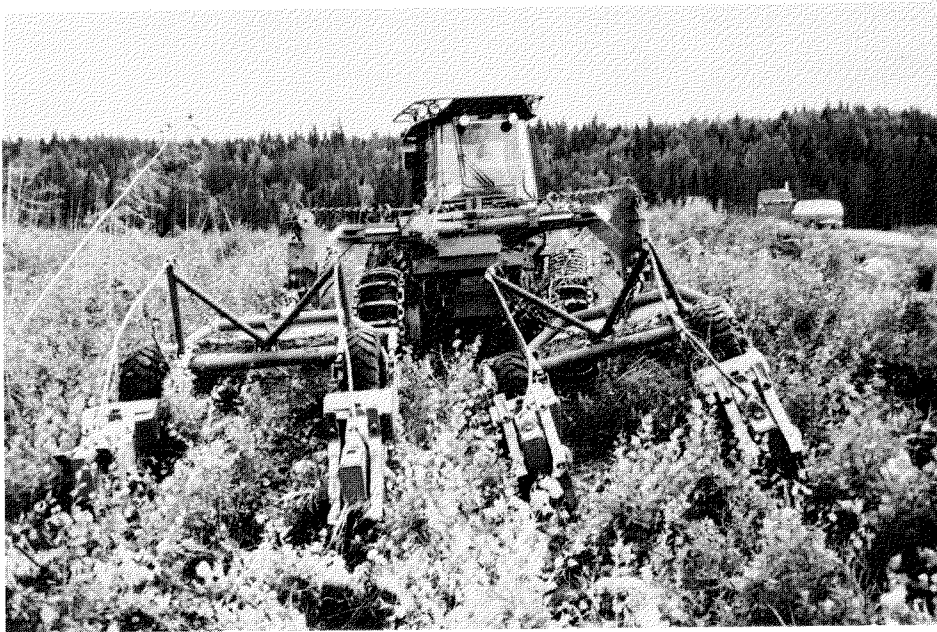
Figure 10. Double unit Cultivator in operation on SCA's limits in Sweden, 1984.

In Sweden, a double Bräcke Cultivator (4 rows, 2-metre spacing) was developed and tested in 1974. A comparison of the single and double Cultivators indicated that the wider unit had economic potential in smooth and flat terrain when the size of the cutovers averaged 10-20 ha or more according to Dalström (1975).

The double unit was more sensitive to steep slopes and rough terrain in terms of reduced driving speed than the single Cultivator. However, this was primarily attributed to the design of the 1974 model which did not allow independent sideways movement of each unit thus restricting the ability of the machine to negotiate slopes and obstacles. As well, the early model was difficult to dismantle and set up for travel between sites.
