Project No. 2166

**An Investigation into Chipped Surface
Quality Problems at Canter Lines**

Alan Wang and Gabor Szathmary
Wood Machining Scientist and Electronics Technologist
Lumber Manufacturing Department

September 2001

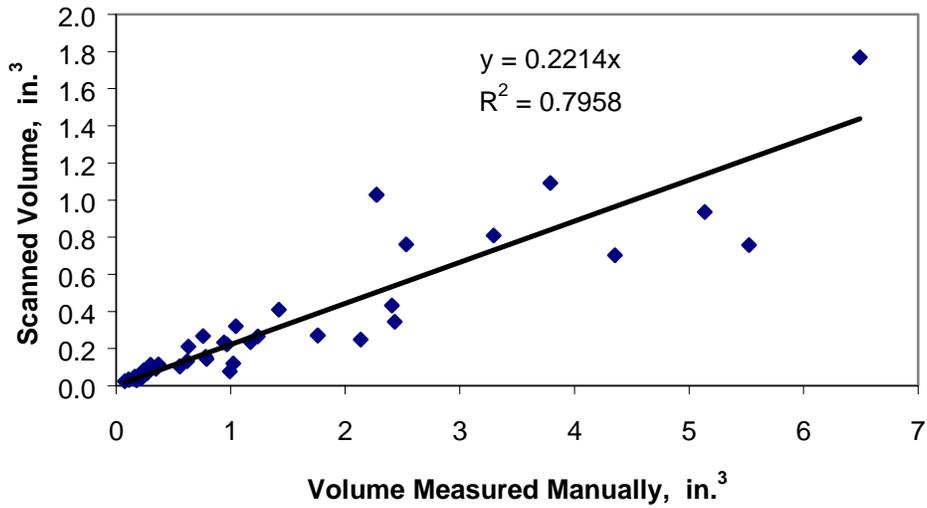
Figure 10 knot tear-out volume, scanned vs. measured values

Figure 10 was used to correlate the manually measured volume of tear-out (depth x length x width) with the actual scanned volume of tear-out (all the data in the test mills was used in the graph). The slope of the trend line was used to convert all the manually measured volume to actual volume in order to evaluate the severity of knot tear-out. The converted scanned knot tear-out volume was divided by knot diameter to normalize the effect of knot diameter on knot tear-out. The larger the quotient, the more severe the knot tear-out is.
