Denis Cormier
Eastern Division

Development of a simultaneous crushing and scarification technique for the treatment of burned sites

Abstract

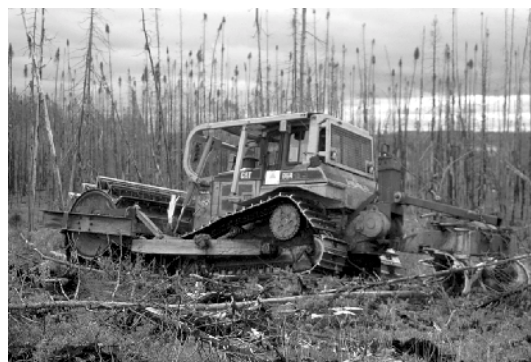
Figure 1. Simultaneous crushing and scarification performed by a bulldozer equipped with a roller-crusher on the front and a passive-disc scarifier pulled behind.

The machine consists of a 138-kW Caterpillar D6R bulldozer whose blade has been replaced with a roller-crusher (Figure 1) built from an old Marden B-10GK tandem roller. The roller, which is equipped with 14 blades, has a diameter of 1.45 m, a width of 3.05 m, and a weight of around 7 tonnes. The blades alternate between 20 and 25 cm high and were spaced approximately 45 cm apart at the cutting edge. The bulldozer also pulled a TTS-35 passive-disc scarifier.
