October 1988

Field Note N°: General-9
Previous Reference Sheet N°: None

BEARING REPAIRS BY INJECTION

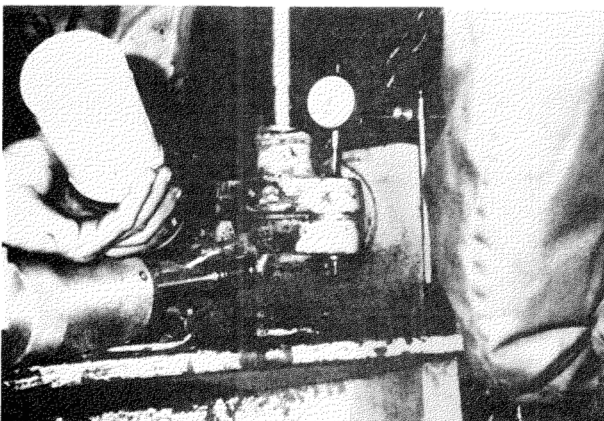
Nu-joint is an acrylic-based polymer which is injected in a molten state through grease fittings into worn bearings to fill any voids and eliminate play (Figure 1). This material is manufactured by Automotive Innovations Ltd. of Denver, Colorado and was introduced into the United States automotive repair market in 1982. It is being used on vehicle front end ball joints, idler arms, tie rod ends, and other swivel joints or pivot-type bushings by organizations such as the U.S. Army and Air Force and the Idaho Department of Transportation. In Canada, C.S.A. certification is currently being sought for highway vehicle use. Off-road applications to date include center pins of articulated loaders and excavator bucket pins but there are many other potential applications, the most likely being boom and implement pins.

Figure 1. Insertion of Nu-joint in bearing.

Injection of the Nu-joint material is done with an air-powered injection tool. The procedure begins with unloading the joint and placing a temporary seal over any openings where the Nu-joint material might escape during injection. Once the joint has been prepared, the grease nipple is removed or a hole is drilled and tapped and the injector nozzle is screwed in place. Next, the bearing is heated to approximately 100°C to prevent the Nu-joint material from cooling before filling all the voids. Bars of Nu-joint, approximately 50 mm long by 16 mm in diameter are then inserted into the nozzle, heated by a torch or electric heater for a few minutes as indicated by a timer and injected.

Once injected and cooled, the Nu-joint material hardens to a non-brittle state with a compressive strength of 11 500 psi (79 000 kPa). The bearing should then be greased according to normal procedures. When the bearing again becomes worn through normal usage, the injection procedure can be repeated.

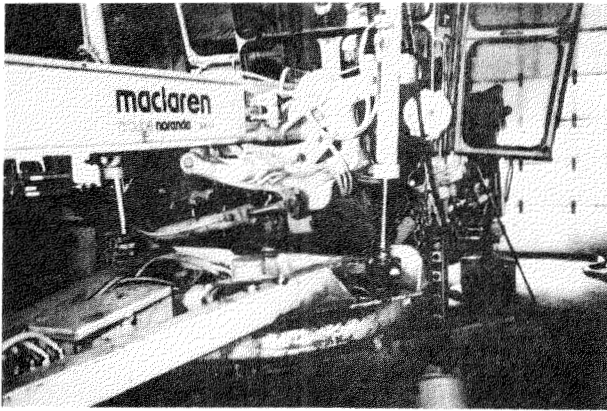
As a test, the blade leveling cylinder ball and cap bearing of a Caterpillar 140G grader was chosen (Figure 2). These bearings, of which there are a left and right on each machine, absorb the majority of the vertical shock loads conveyed through the grader blade. Typically, they are rebuilt every 500 to 800 operating hours with steel or Teflon bushing insertions.

Figure 2. Blade leveling cylinder of Caterpillar grader.

The installation procedure was completed in 45 minutes. In fact, this bearing was more difficult to seal than pin and bushing type bearings because of its design. A clamping jig for this type of bearing would speed up the process.

After the joint cooled, no play could be measured as compared to a 5-mm play prior to injection. Three bars of Nu-joint were required, which represents a cost of \$90. The normal rebuild cost for this joint is \$20 for a bushing and 30 minutes of labour unless the trunion ball must be replaced. If so, the cost rises to \$220 for the trunion ball and bushing and 4 hours of labour. For the purpose of the test, the other leveling rod bearing was rebuilt with a conventional bushing. In a year, it will be possible to compare the durability of the two bearings repairs.
